The Grand Reserve  
Addendum for Bidding #2

In general accordance with our Agreement with you dated November 4, 2016, we have completed our review of a select portion of the four primary elevations from a swing stage at the above referenced building. This 21-story building is located at the northeast corner of the intersection of Grand Avenue and E. 10<sup>th</sup> Street, and was built in 1921. The purpose of this review is to visually examine the condition of the building facade and provide repair recommendations with cost estimates based on our findings. Our on-site reviews occurred on March 2 to March 17, 2017.

**FORMER FEDERAL RESERVE BUILDING  
925 GRAND BLVD  
KANSAS CITY, MO**

**MARCH 31, 2017  
JOB #2017-0368**

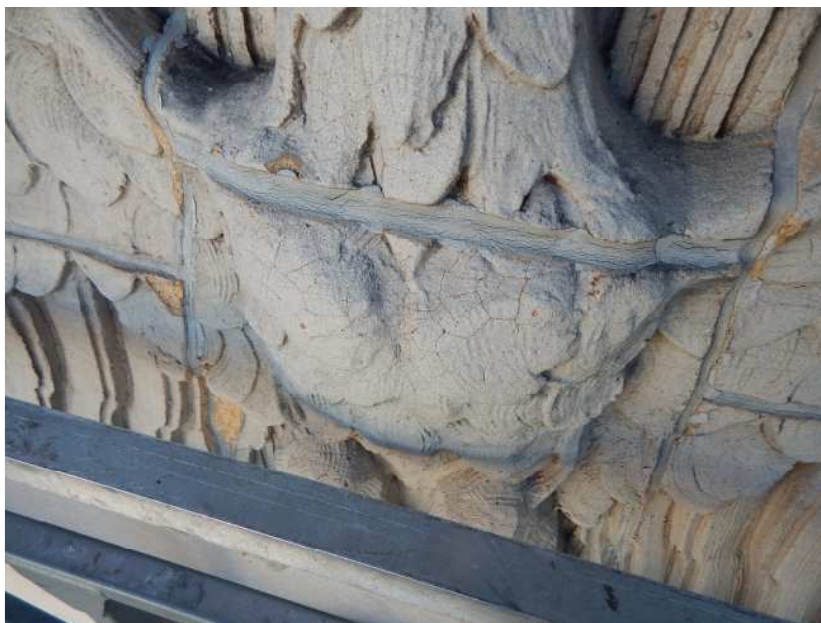
Ornamental elements on the facade are constructed of terra cotta masonry. Crazeing was observed on the surface of the terra cotta glazing (see photo # 2, 5 and 11). Additionally, past attempts at joint repair of the terra cotta has led to the glazing being ground off the terra cotta directly adjacent to the joint (see photo # 30 and 31). The glazing on the terra cotta, when intact, protects the unit from moisture absorption. When the glazing is deteriorated or damaged, there is more potential for moisture absorption into the unit which can lead to deterioration. However, many of the decorative terra cotta units appear to be original with minimal signs of deterioration after almost 100 years of service. Therefore, we are not recommending that the terra cotta be recoated, but monitored for future signs of deterioration.

2. West Elevation:  
Example of crazing of  
terra cotta coating.  
Given the age and lack  
of spalling/other forms  
of deterioration,  
recoating is not  
recommended at this  
time.

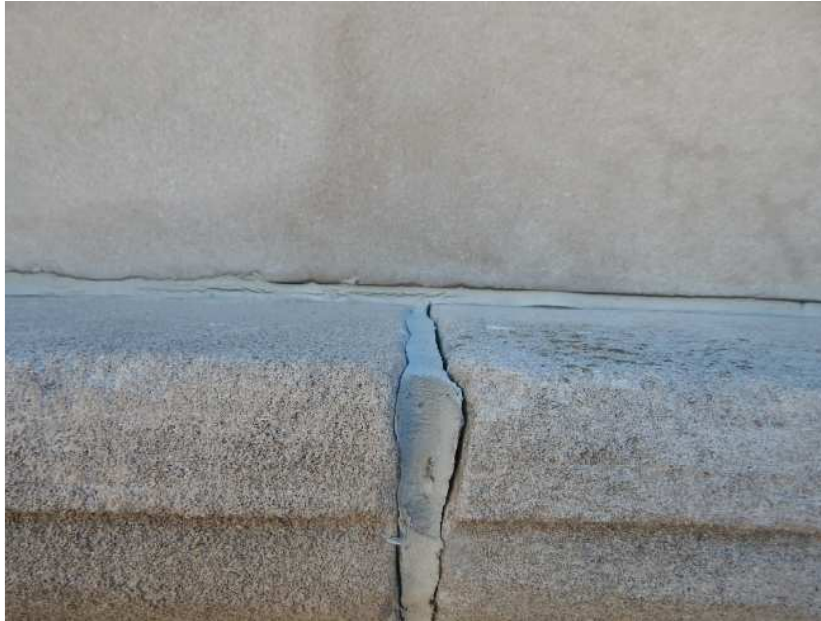
The south and west elevations at the street corner are the more ornate. They are clad in a combination of cut stone, cast stone and terra cotta masonry. The mortar joints between these elements had been ground back and sealant joints installed. In general, the bond between the sealant and the masonry has failed which can allow moisture into the joint (see photo # 3, 23 and 24). Additionally, significant deterioration of the remaining mortar in the joints was observed in the areas below the skyward facing joints, most notably at the cornices.

3. West Elevation: Typical joint between masonry units. The original mortar has been replaced with a sealant joint that has failed. We recommend repointing all joints on the west and south elevations.

These sealants should be removed from all joints not only because of deterioration, but also to allow moisture that may infiltrate the system to escape. Joints in a vertical plane should be repointed with mortar and skyward facing horizontal joints that shed moisture more slowly should have sealants replaced.

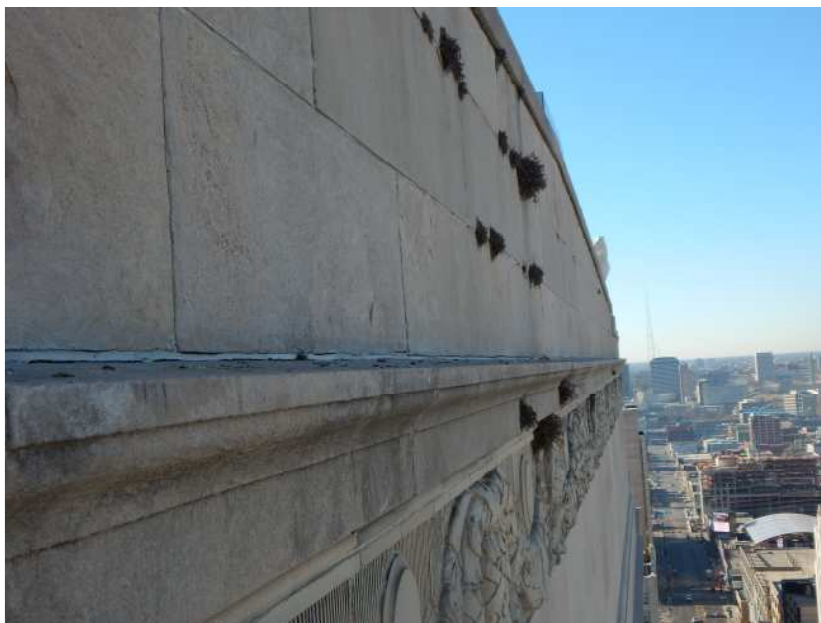
4. West Elevation: Example of growth protruding from the joints between stones at the roof elevation.

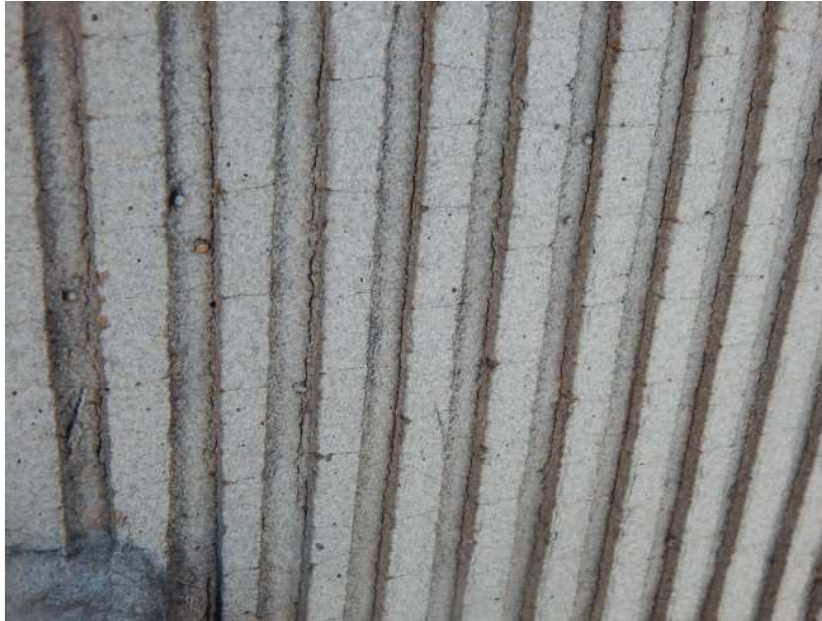
5. West Elevation: Typical vertical crack in glazing of fluted terra cotta element. Since other signs of visible damage were not observed at this location, recoating is not recommended.

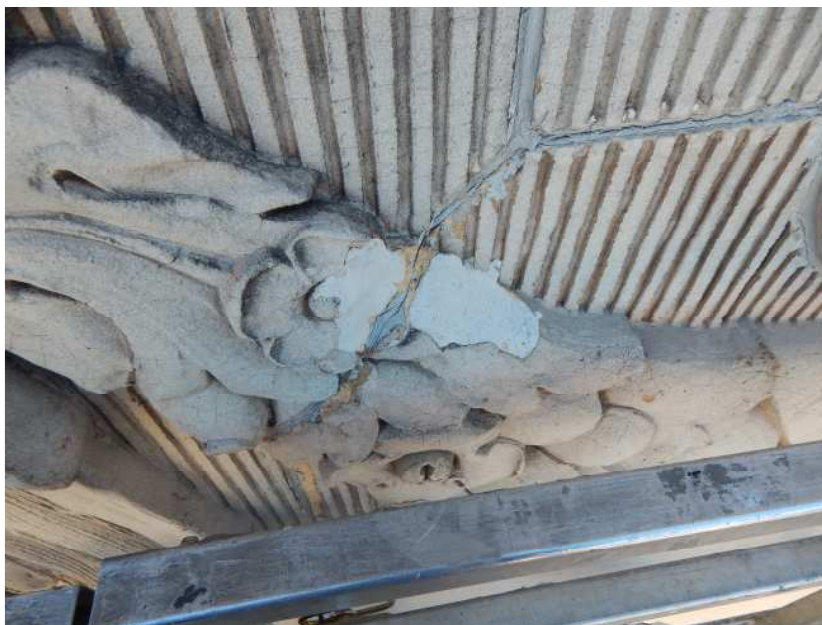
6. West Elevation: Damaged and patched terra cotta directly adjacent to joint.

However, glazing should be repaired where it has been damaged from previous repair attempts. This can be performed when the existing joints between the masonry units are being repaired.

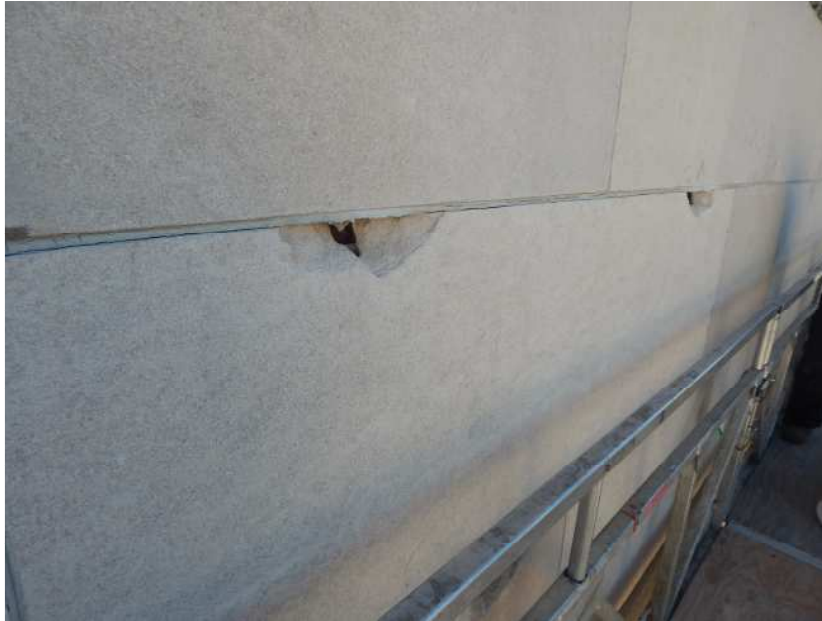
At several locations, most notably at the building corners, cracking and spalling of the stone veneer was observed. At the north end of the west elevation, rusted stone ties doveled into the top of the stone were observed at the locations where stone was spalling (see photo # 7, 8 and 25). Moisture infiltrating the veneer has caused corrosion of these elements. As the dowels corrode, the layers of rust expand and exert pressure on the stone from inside the dowel hole, which create the spalling observed.

7. West Elevation:  
Corroded dowel in stone  
panel causing spalling of  
stone.

The stone ties should be removed to prevent further spalling and movement in the veneer due to their corrosion. The dowels can be replaced with appropriate helical anchors installed through the stone and into the backing behind. The interior finishes should be removed to expose the masonry backing so the pull-out capacity of the helical anchors can be tested. This information will be used to determine the number of anchors required to replace the stone ties. For budgeting purposes, values from manufacturer's load tables can be used to determine the required number of helical anchors.

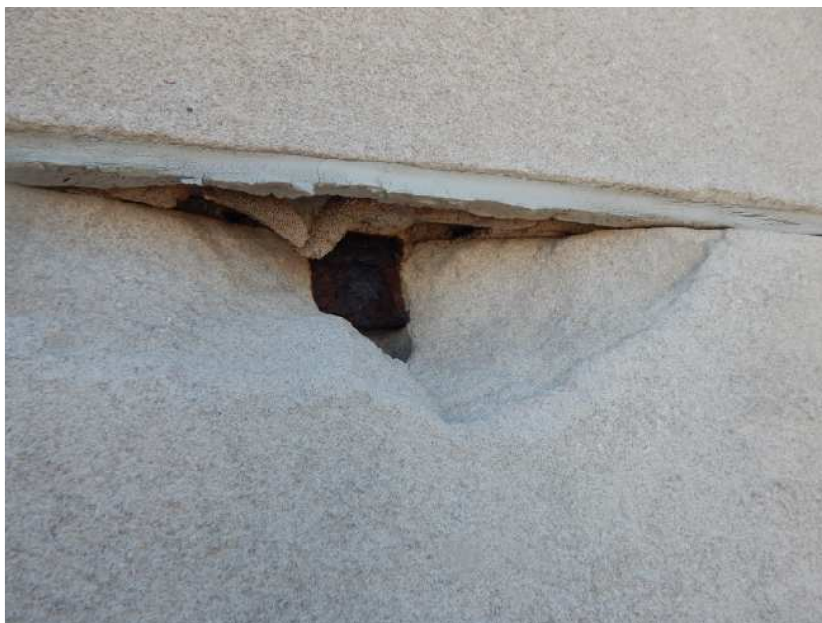
8. West Elevation: Close-  
up of photo #7.

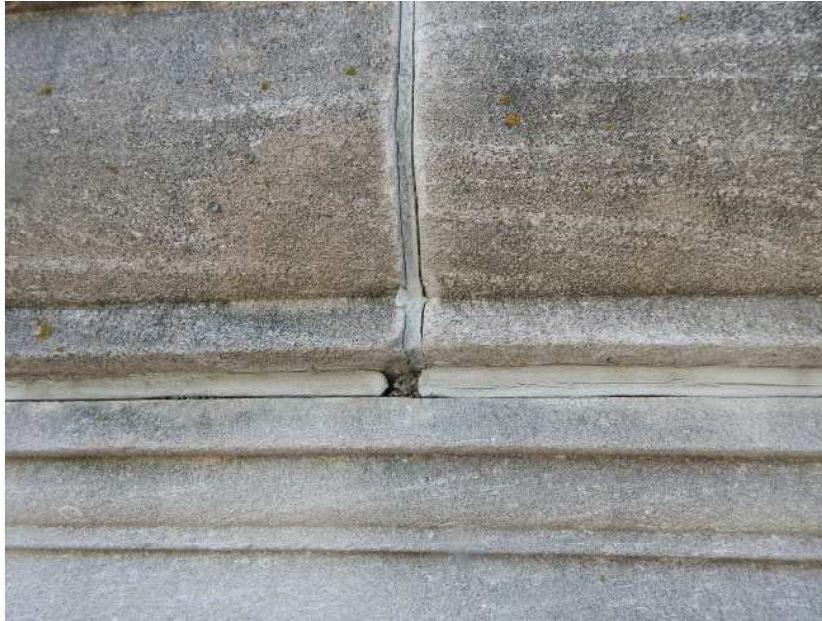
At some horizontal joint lines, weep ropes were observed within the sealant joint. The spacing of the weeps at these locations varied from 2 feet to 6 feet on center. When the joints are repaired, weeps need to be added at these horizontal joint locations to provide a maximum weep spacing of 16 inches on center.

9. West Elevation:  
Evidence of weep in  
horizontal joint.

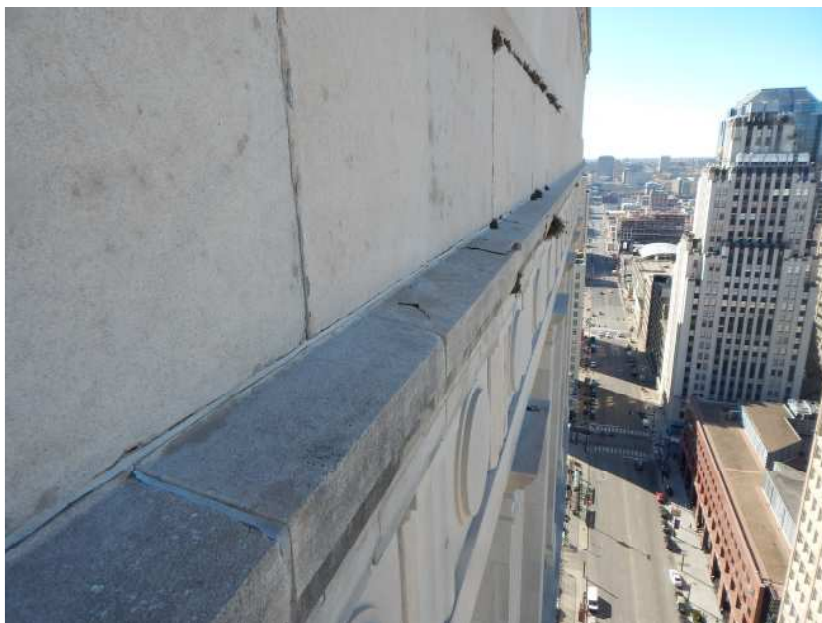
10. West Elevation: Organic  
growth observed in  
mortar joints on the  
exterior side of the  
parapet.

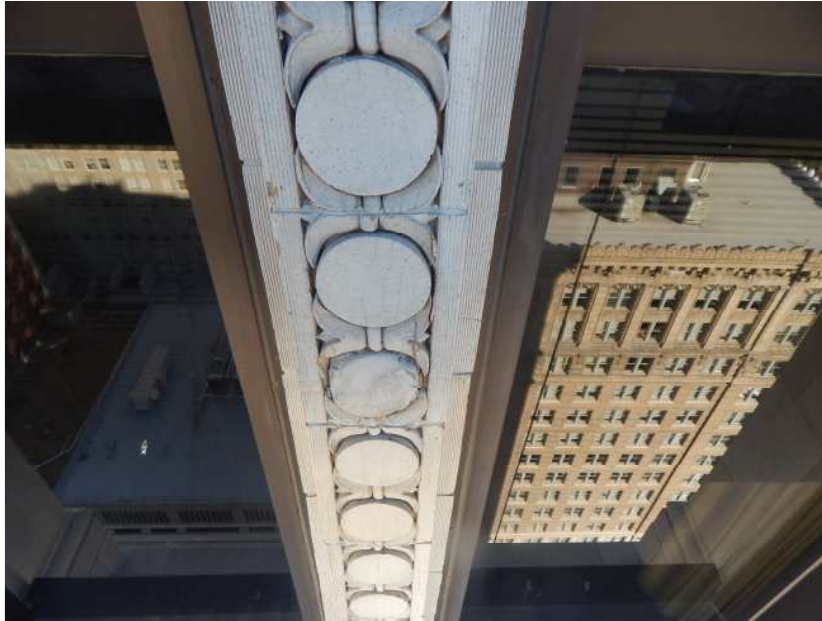
11. West Elevation:  
Example of crazing  
observed in terra cotta  
medalions.

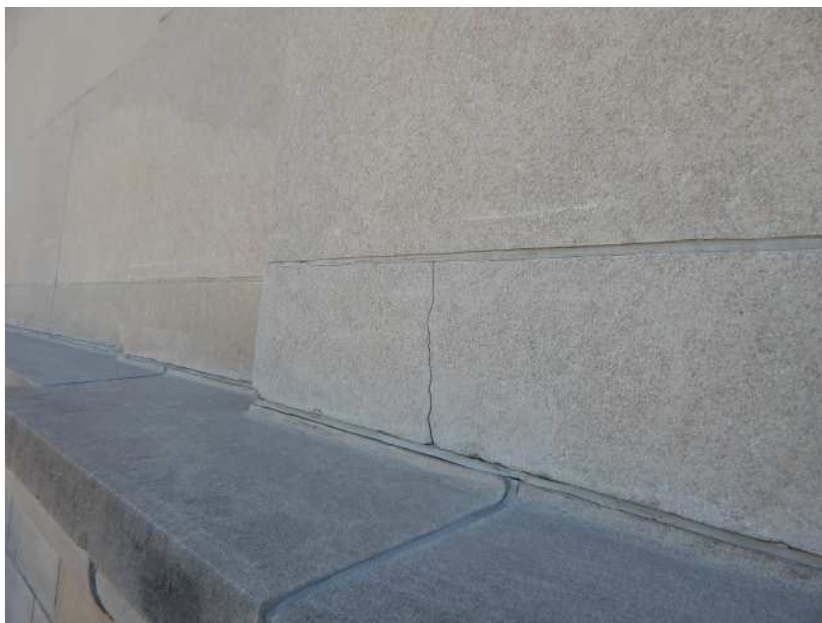
12. West Elevation:  
Example of crack  
observed in stone.

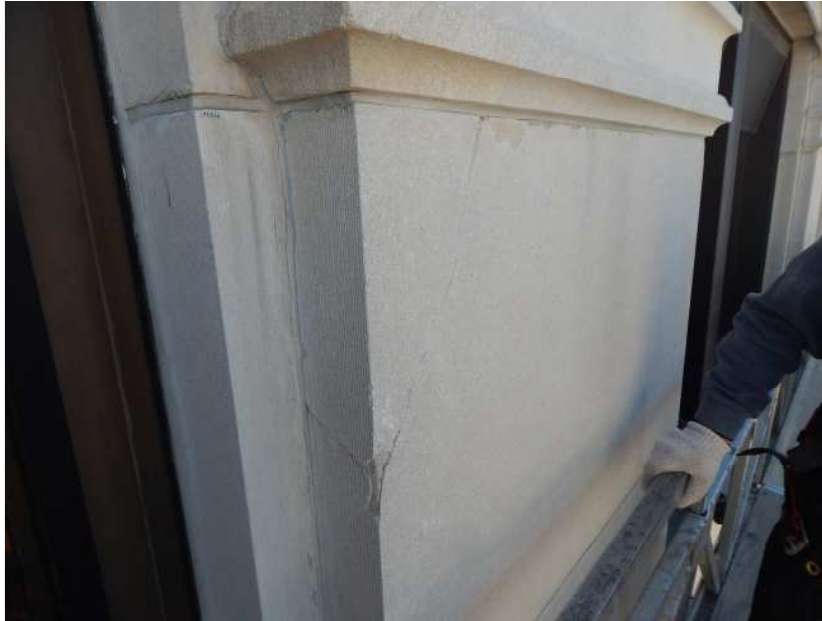
13. West Elevation:  
Example of crack  
observed at corner of  
stone.

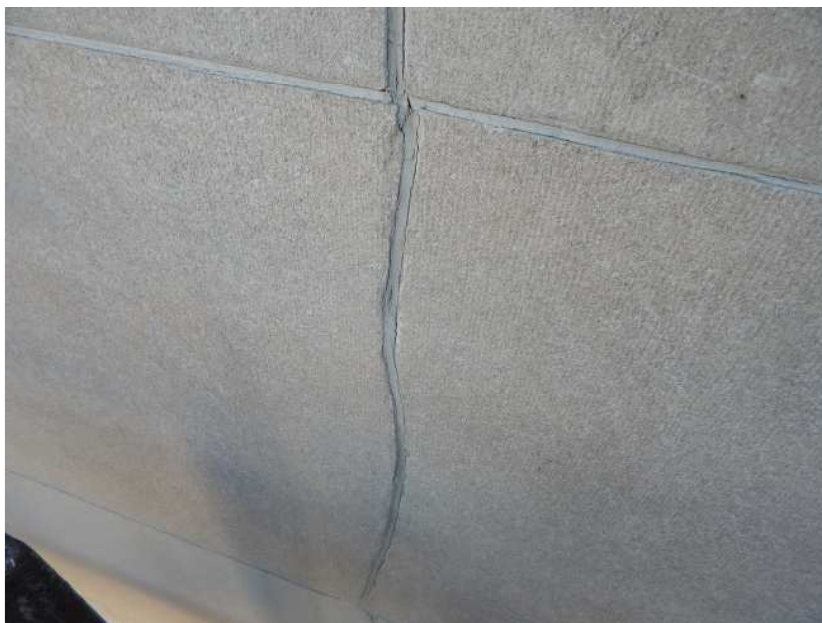
14. West Elevation:  
Example of crack  
observed in stone.

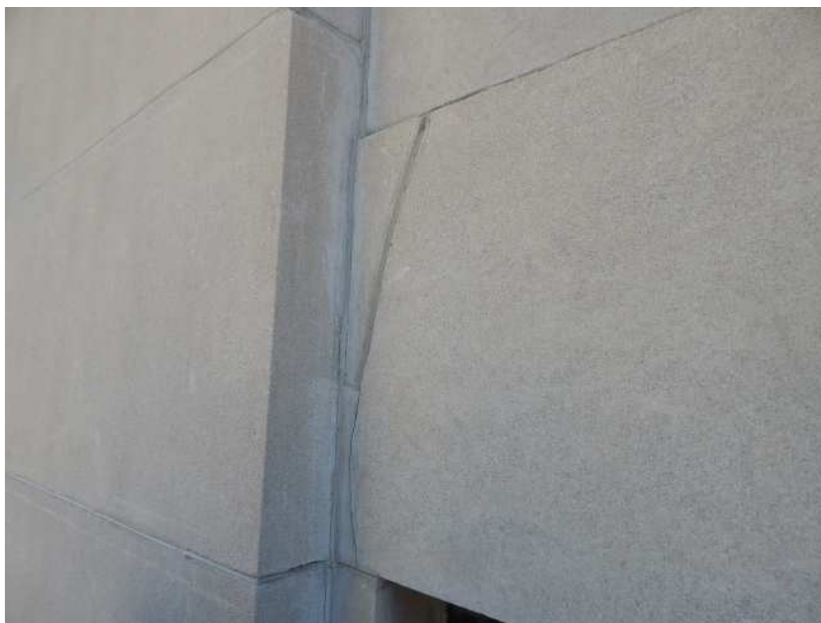
16. West Elevation:  
Example of crack  
observed in stone header  
above window. This  
condition was observed  
at several locations.

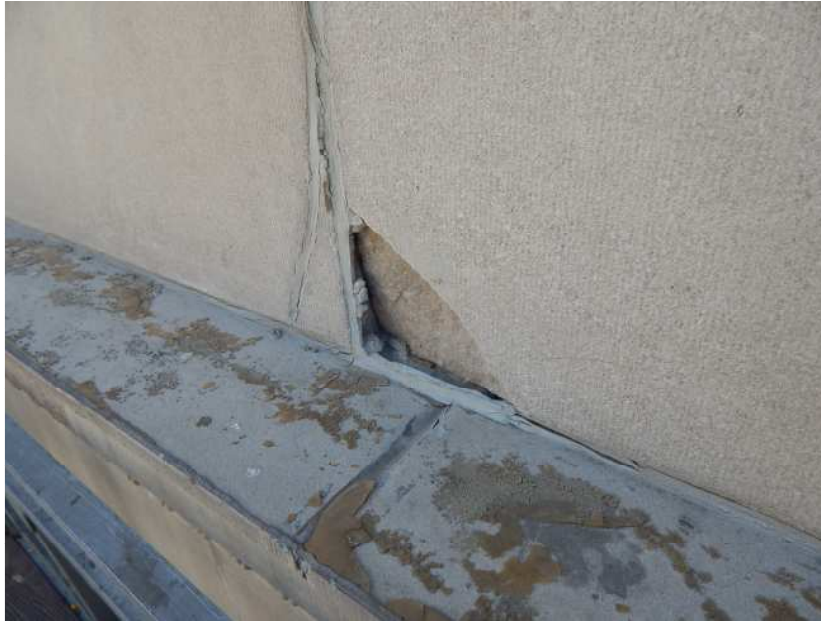
17. West Elevation: Corner of stone panel spalled.

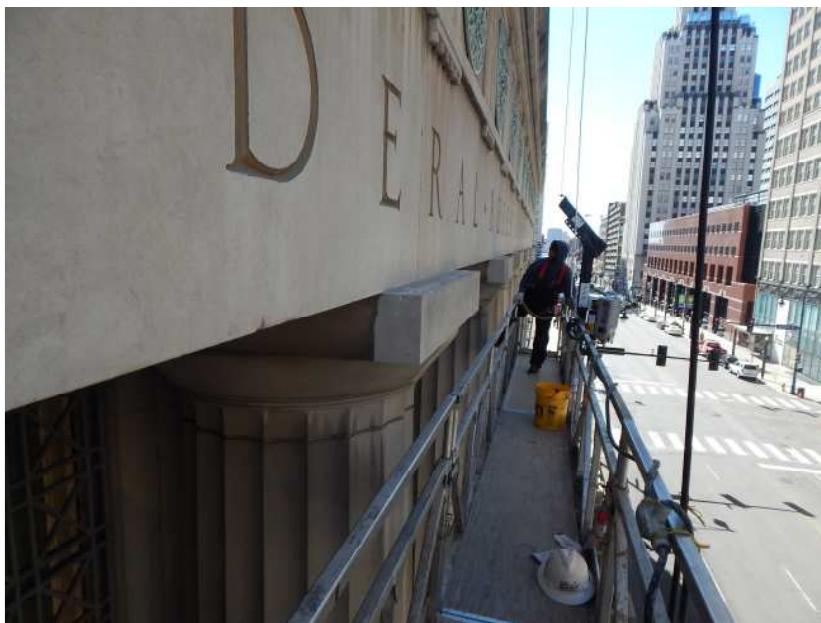
18. West Elevation: Column capitals have been patched in the past.

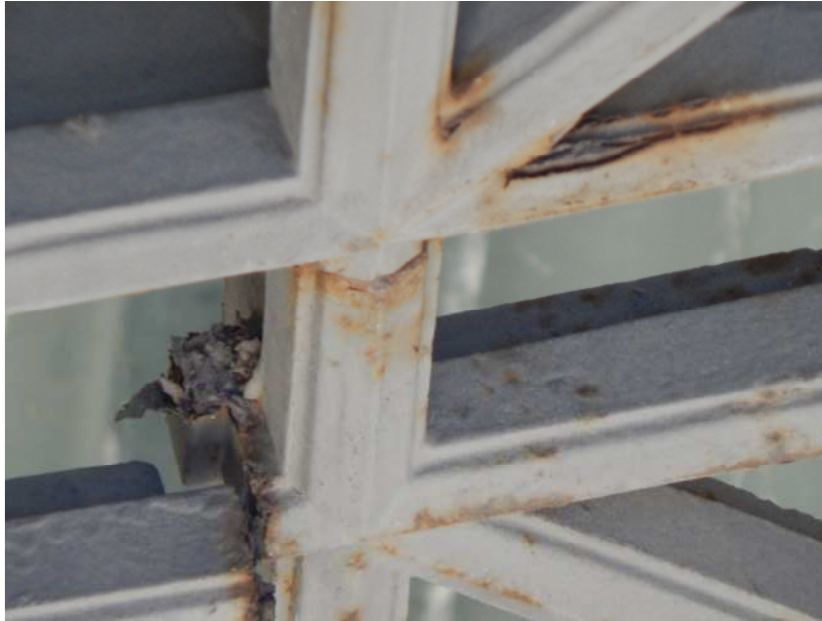
19. West Elevation:  
Corrosion observed in  
steel grating over  
windows.

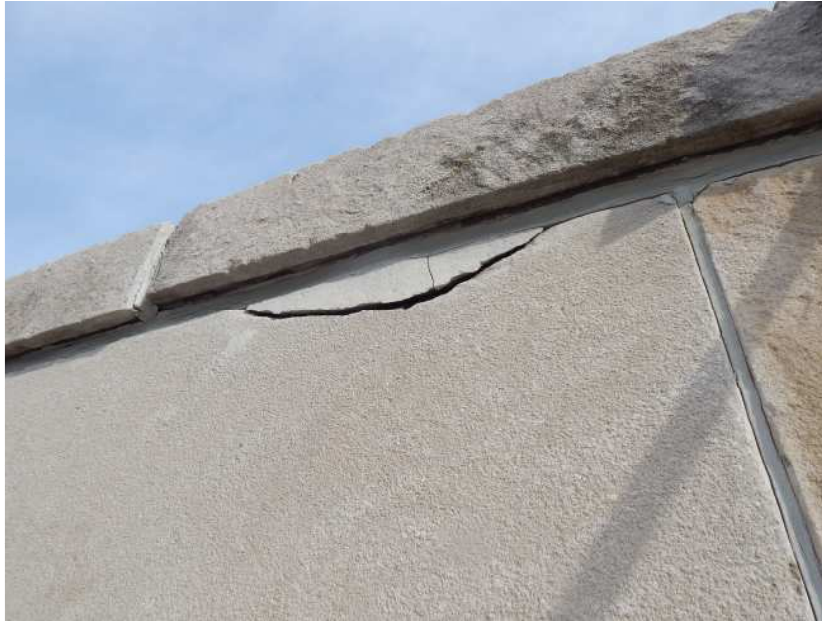
21. South Elevation: Patch in previously repaired stone is failing.

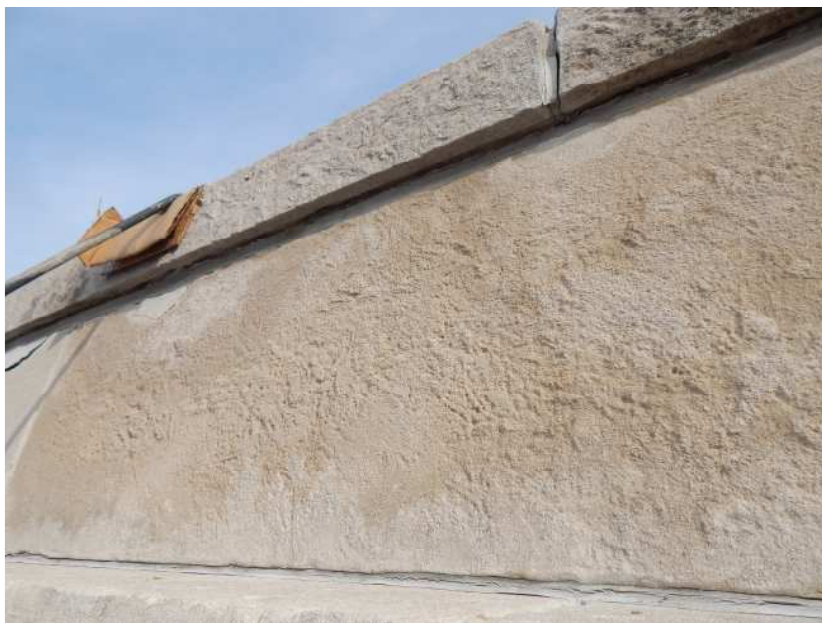
22. South Elevation:  
Example of erosion  
observed on face of  
stone.

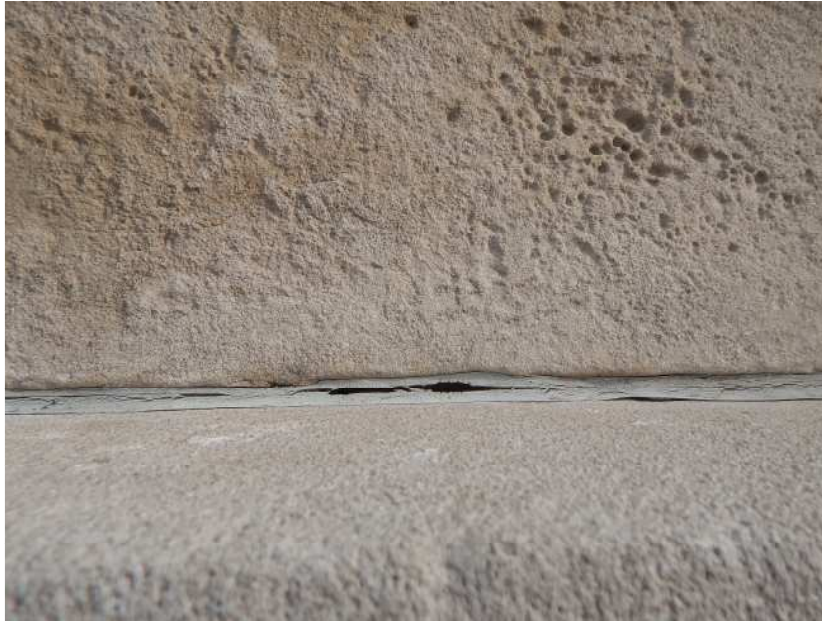
23. South Elevation:  
Example of  
deteriorated/split sealant  
joint.

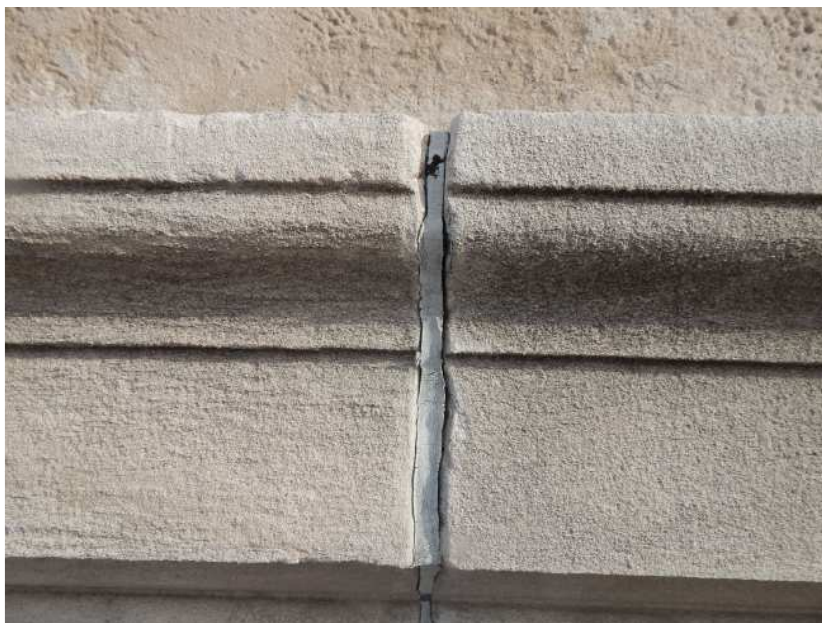
24. South Elevation:  
Example of  
deteriorated/split sealant  
joint.

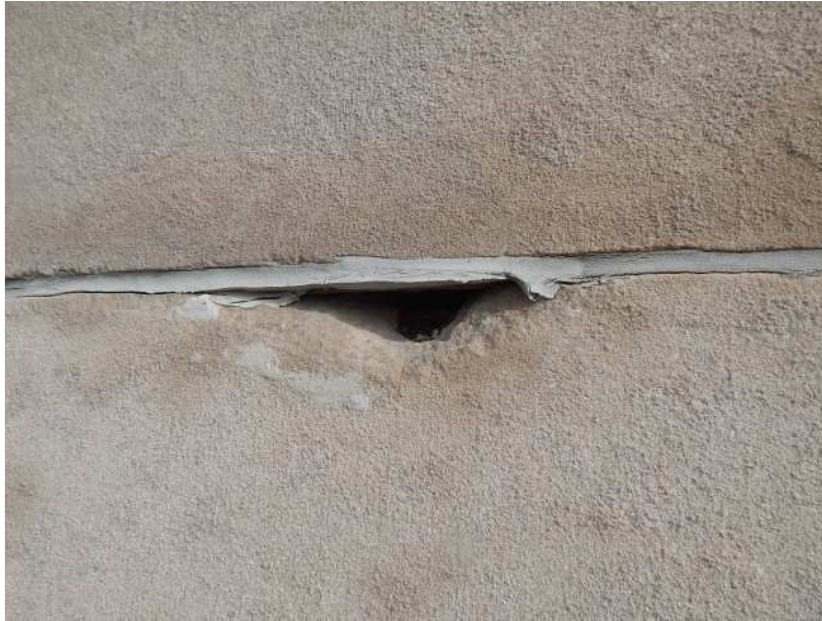
25. South Elevation:  
Corroded dowel causing  
spalling of stone.

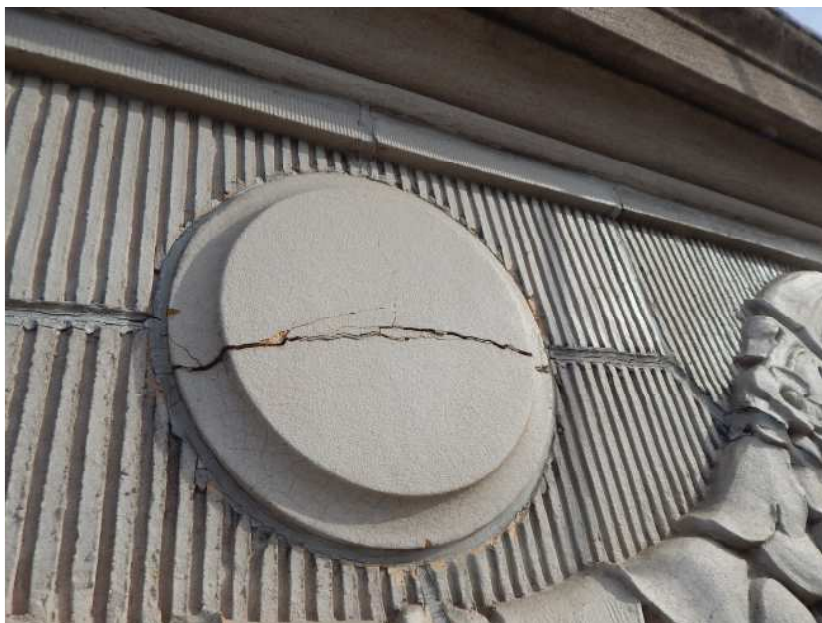
26. South Elevation: Crack  
through terra cotta  
medallion.

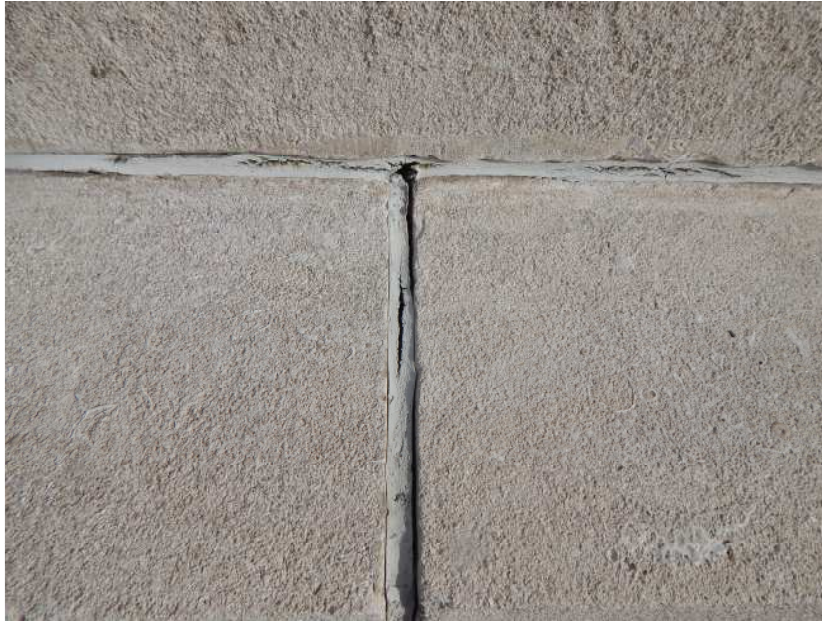
27. South Elevation:  
Example of  
deteriorated/split sealant  
joint.

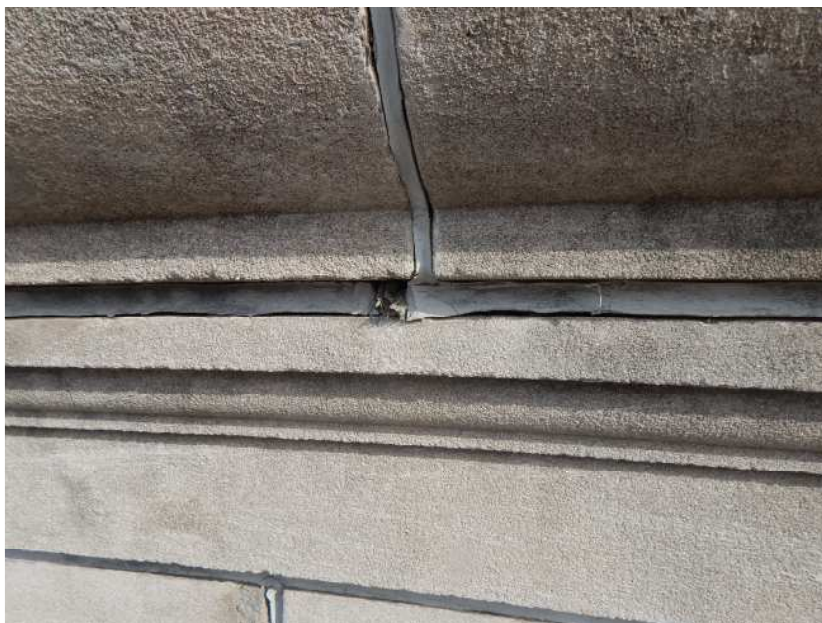
28. South Elevation: Weep  
observed in joint.

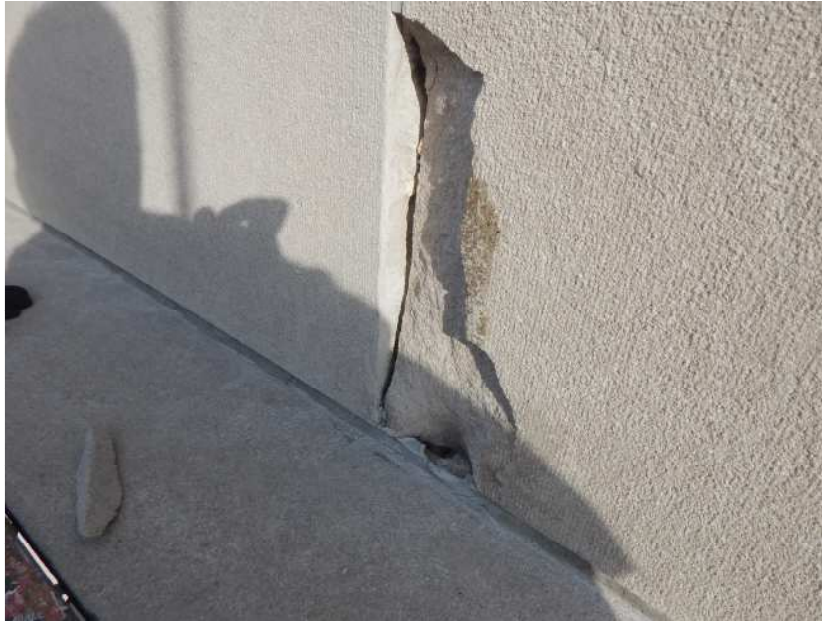
29. South Elevation:  
Example of spall  
observed at corner of  
stone.

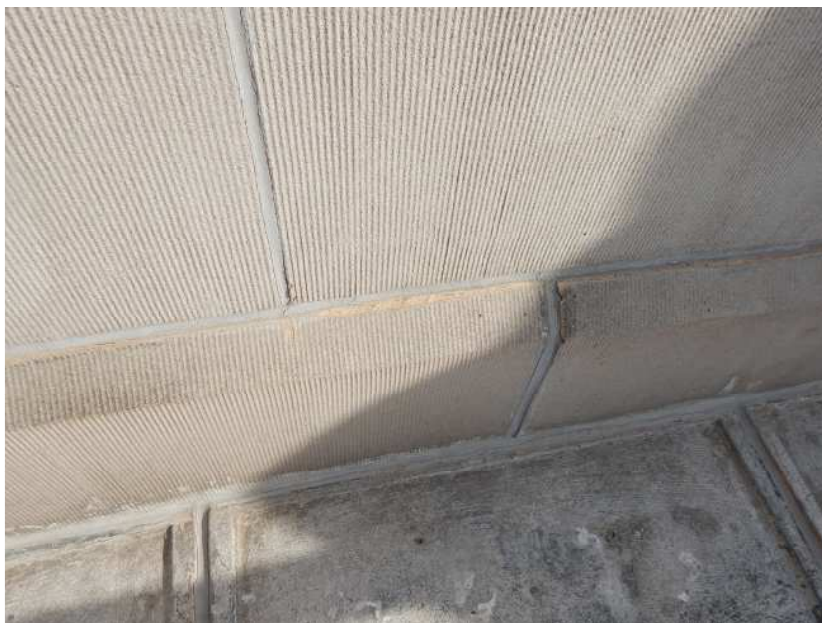
30. South Elevation:  
Previous repair to terra  
cotta joint have  
removed the glazing  
adjacent to the joint.

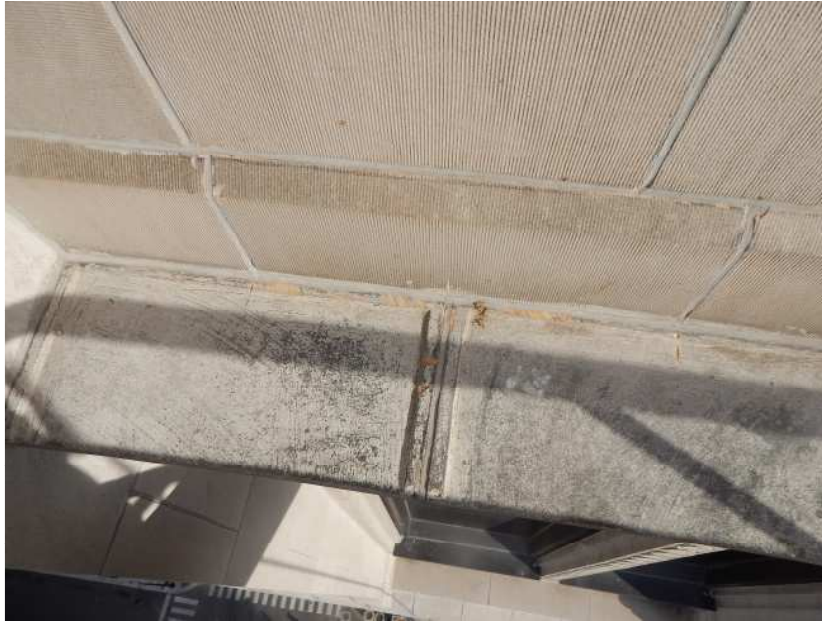
31. South Elevation:  
Previous repair to terra  
cotta joints have  
removed the glazing  
adjacent to the joint.

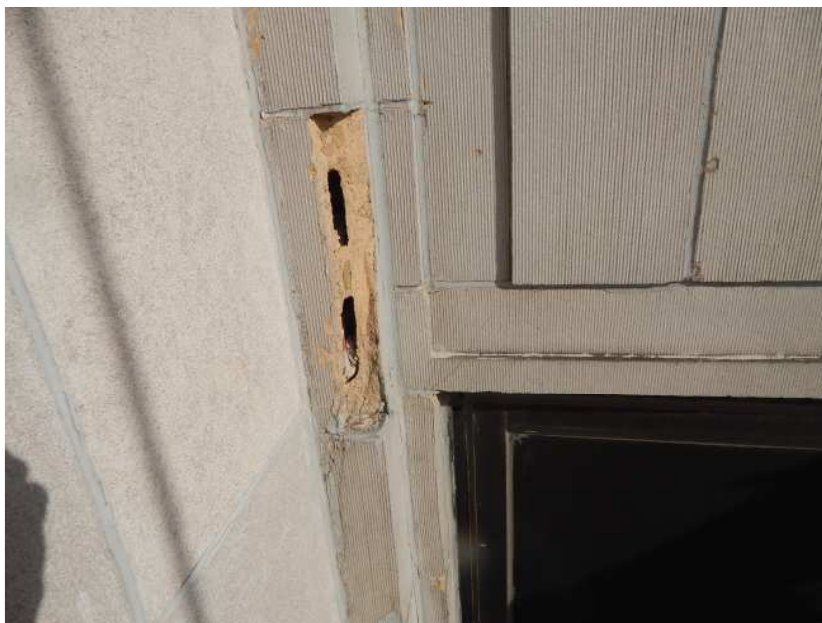
32. South Elevation:  
Damage to terra cotta  
element adjacent to  
window.

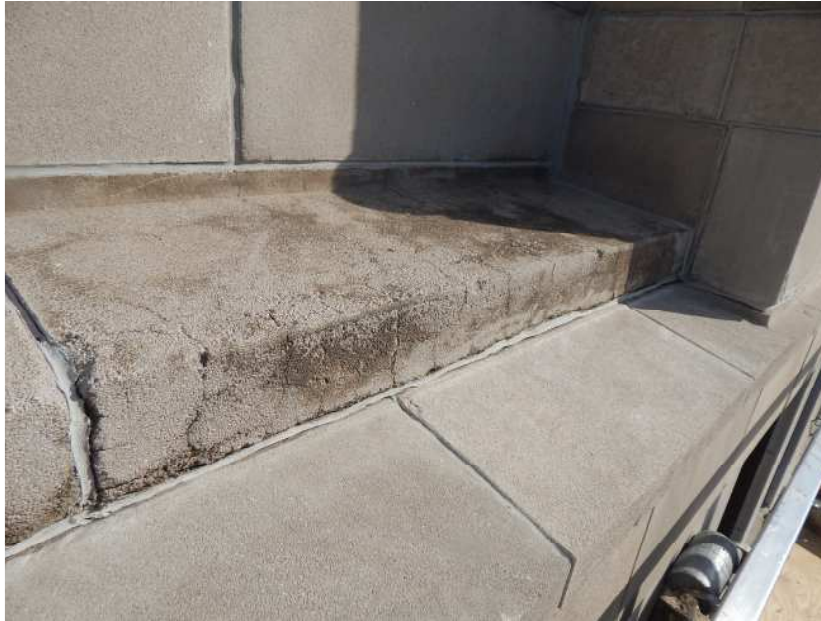
33. South Elevation: Early signs of freeze-thaw damage in unit below window.

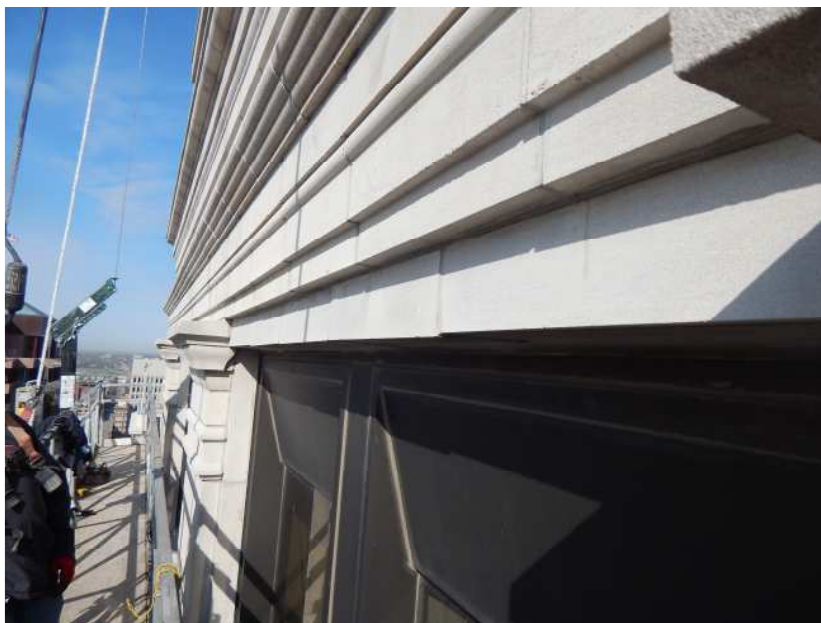
34. South Elevation: Deflection in supporting structural steel has visible in deflection of terra cotta elements it is supporting. Note that no cracking or signs of moisture intrusion were observed at this location to indicate that this is caused by deterioration of the structural steel element.

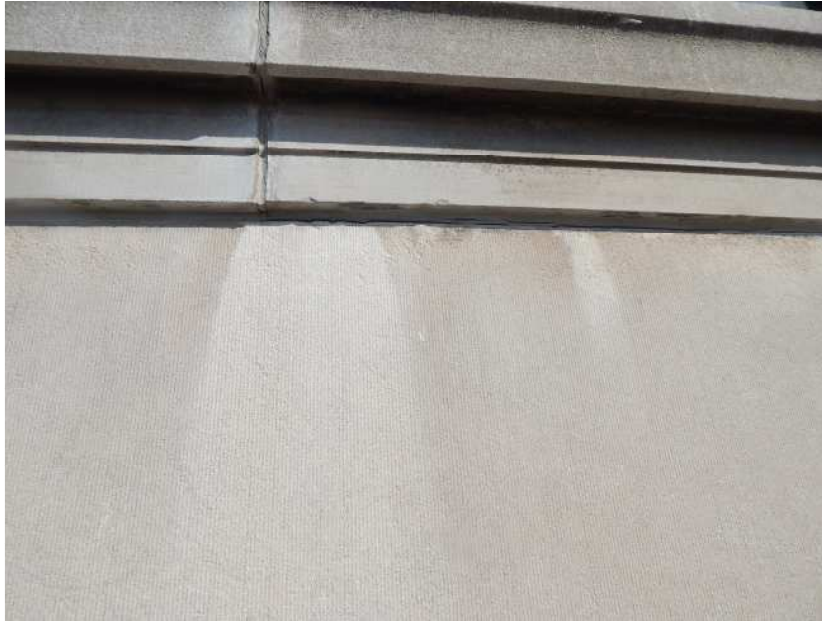
35. South Elevation: Stains on stone an indication of moisture weeping out through joint.

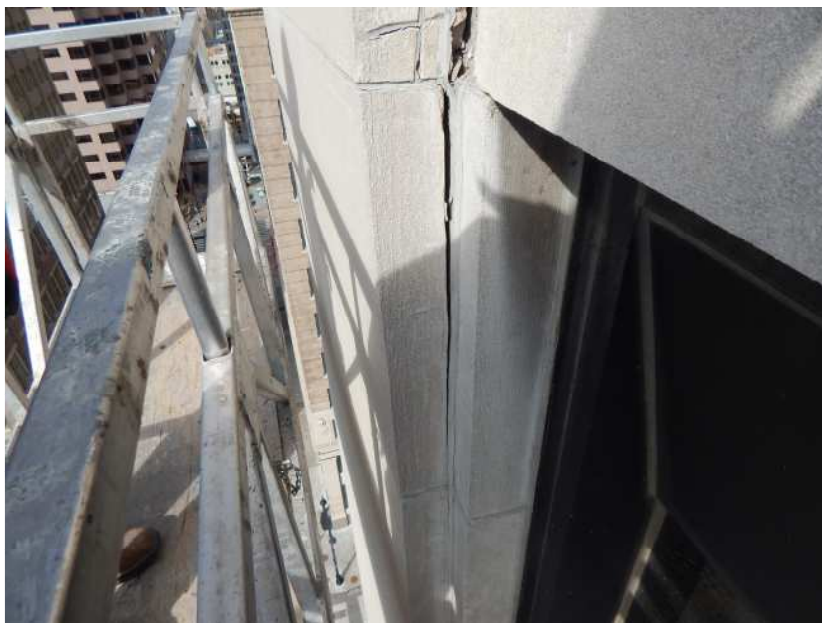
36. South Elevation: Top of stone pushing out from wall at the corner of a window.

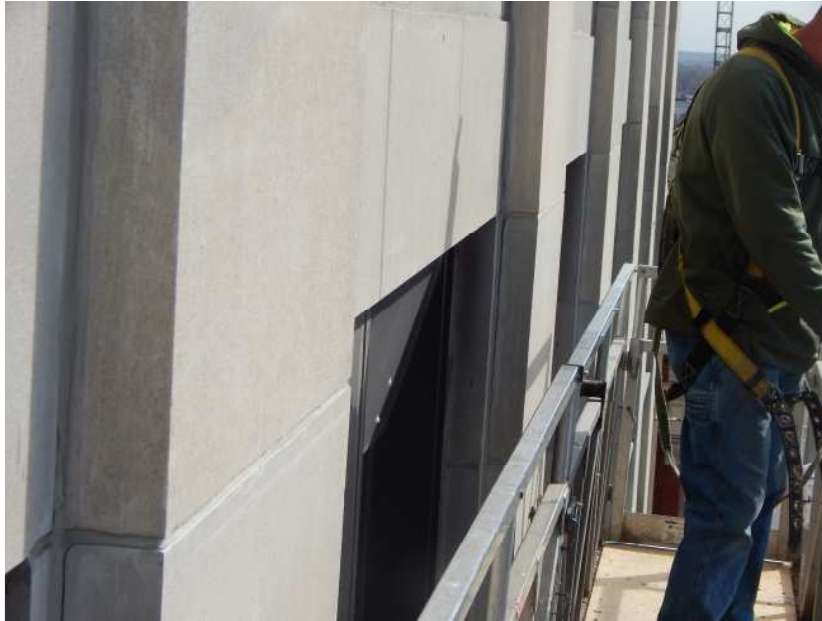
37. South Elevation:  
Condition observed in  
photo #36 observed at  
other locations to  
varying degrees.

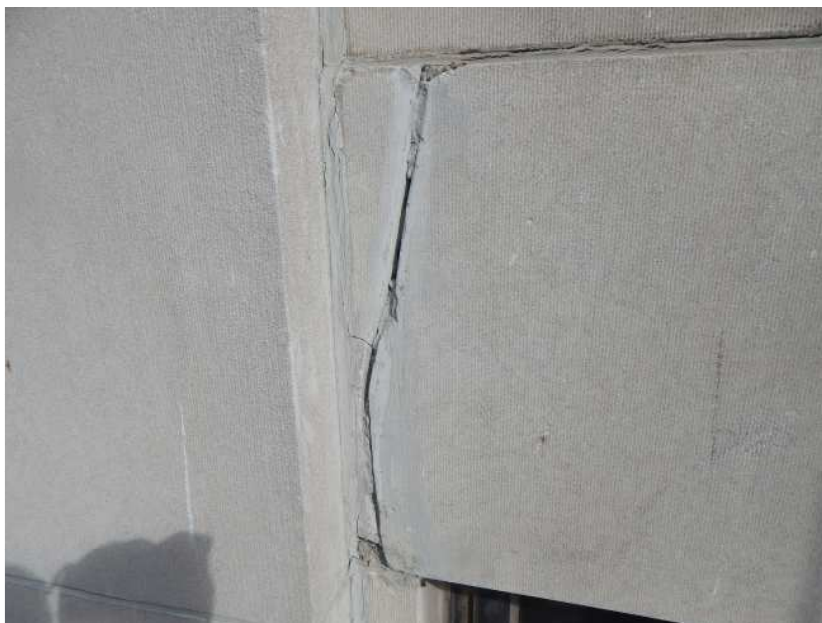
In addition to the spalling of the stone, cracks were observed at the ends of the stone elements above the windows, most notably on the south elevation. The existing building drawings indicate steel angles utilized to support the stone at these locations. However, removal of finishes and masonry from the interior at this location revealed a steel element that is not indicated on the existing structural drawings (see photo # 38 and 41 - 43).

These cracks are due to movement in the stone from corrosion of the steel element concealed by the joint below the stone. Given the number of locations where this type of crack has been observed, one of the stone headers should be removed and replaced to allow for further investigation. The base budget costs for the work at these locations assume that the steel element is a form of dowel that can be ground out of the joint and the stone pinned back to the structure with helical anchors. The alternate budget costs for this work assume that the stone must be removed and replaced to properly repair the corroded steel element.

38. South Elevation:  
Common crack observed  
in stone header above  
window.

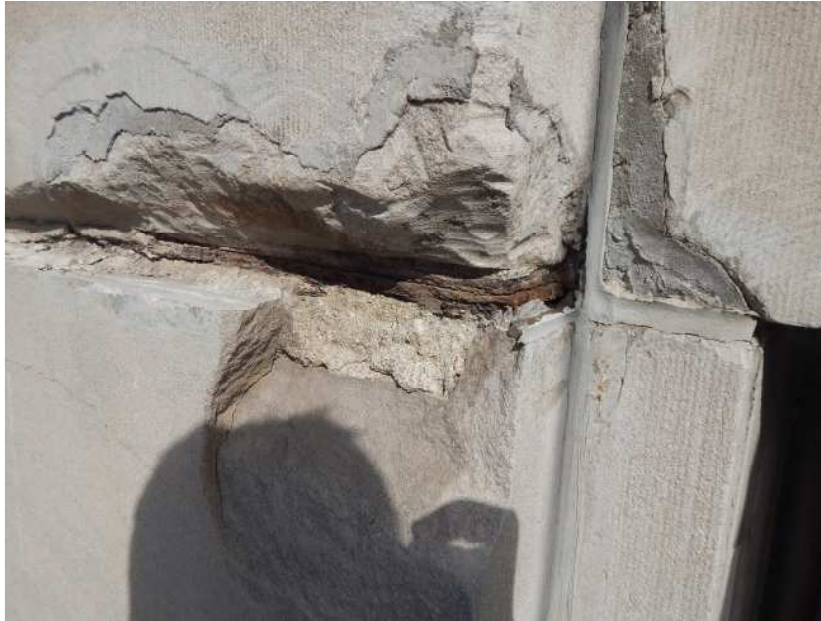
Significant deterioration of steel support angles was also observed on the south elevation at the west end. At these locations, deterioration of a continuous angle, approximately 6 feet in length was observed (see photo # 39, 40 and 44). The angles at these locations will need to be removed and replaced.

39. South Elevation:  
Corroded steel observed  
in joint between stone  
elements adjacent to top  
of window.

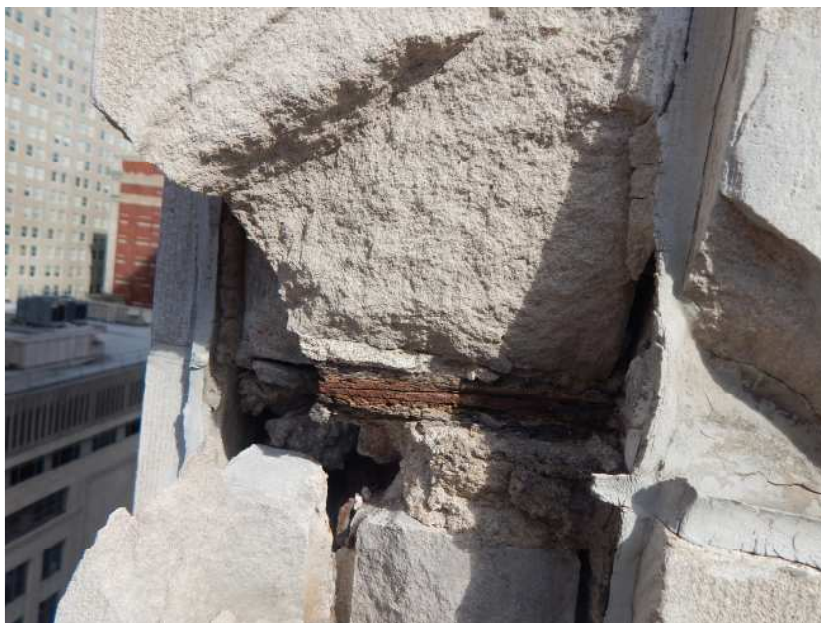
40. South Elevation:  
Corroded steel observed  
in the joint at the  
southwest corner of the  
building.

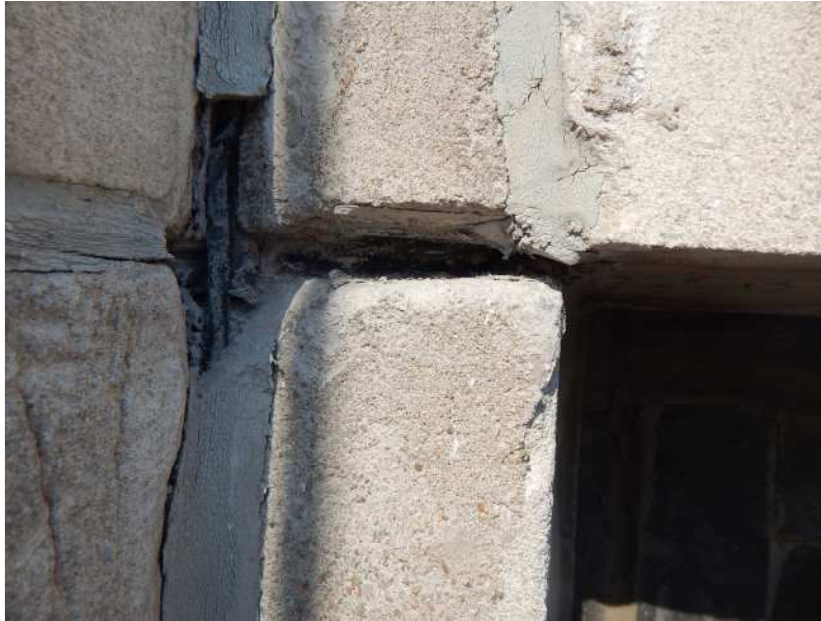
41. South Elevation:  
Corroded steel observed  
below end of window  
header.

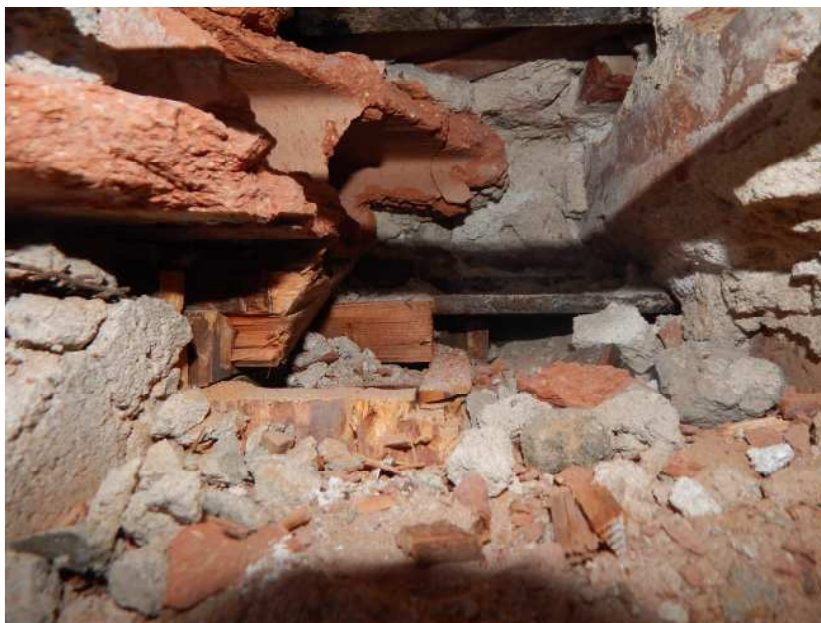
42. South Elevation:  
Condition of steel  
observed at pilaster  
adjacent to window  
observed by removal of  
interior finishes and  
masonry.
