The Grand Reserve  
Addendum for Bidding #2

In general accordance with our Agreement with you dated November 4, 2016, we have completed our review of a select portion of the four primary elevations from a swing stage at the above referenced building. This 21-story building is located at the northeast corner of the intersection of Grand Avenue and E. 10<sup>th</sup> Street, and was built in 1921. The purpose of this review is to visually examine the condition of the building facade and provide repair recommendations with cost estimates based on our findings. Our on-site reviews occurred on March 2 to March 17, 2017.

**FORMER FEDERAL RESERVE BUILDING  
925 GRAND BLVD  
KANSAS CITY, MO**

**MARCH 31, 2017  
JOB #2017-0368**

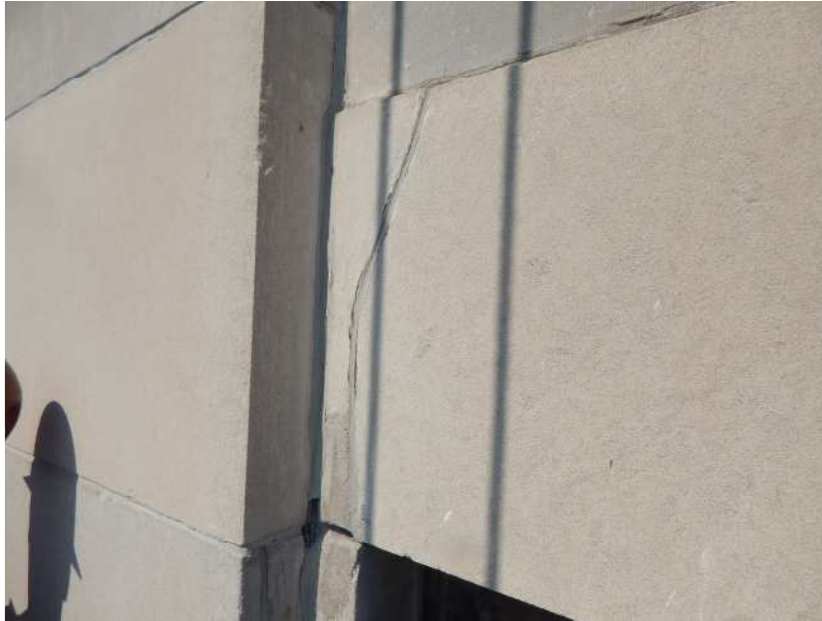
In addition to the spalling of the stone, cracks were observed at the ends of the stone elements above the windows, most notably on the south elevation. The existing building drawings indicate steel angles utilized to support the stone at these locations. However, removal of finishes and masonry from the interior at this location revealed a steel element that is not indicated on the existing structural drawings (see photo # 38 and 41 - 43).

These cracks are due to movement in the stone from corrosion of the steel element concealed by the joint below the stone. Given the number of locations where this type of crack has been observed, one of the stone headers should be removed and replaced to allow for further investigation. The base budget costs for the work at these locations assume that the steel element is a form of dowel that can be ground out of the joint and the stone pinned back to the structure with helical anchors. The alternate budget costs for this work assume that the stone must be removed and replaced to properly repair the corroded steel element.

43. South Elevation:  
Common crack observed  
in stone header above  
window.

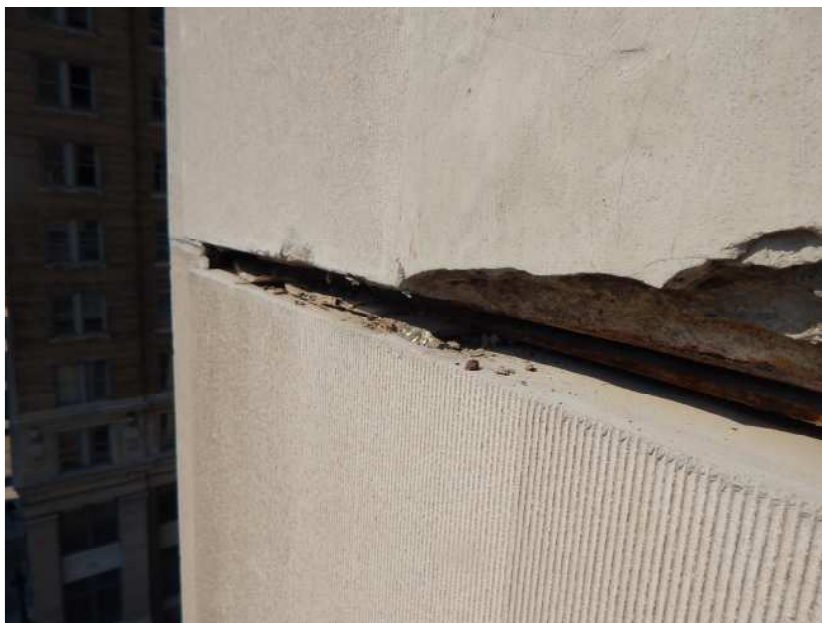
Significant deterioration of steel support angles was also observed on the south elevation at the west end. At these locations, deterioration of a continuous angle, approximately 6 feet in length was observed (see photo # 39, 40 and 44). The angles at these locations will need to be removed and replaced.

44. South Elevation:  
Spalling of stone reveals  
corrosion of supporting  
steel at the west end of  
the south elevation.

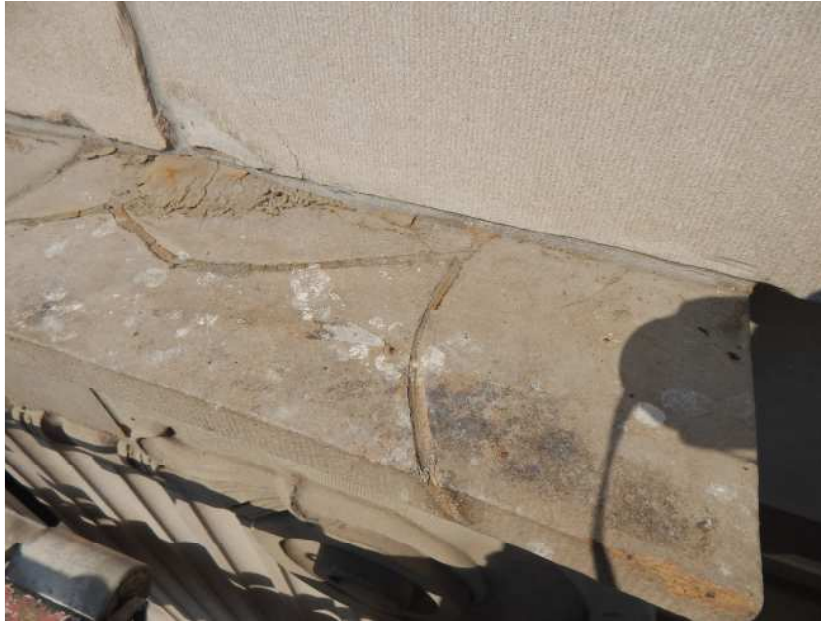
45. South Elevation:  
Cracking observed in  
column capital.

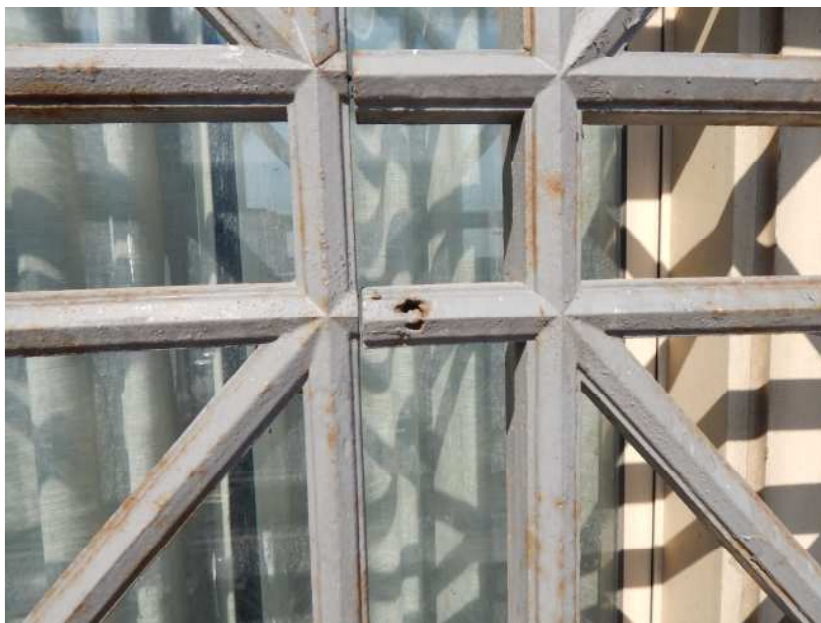
46. South Elevation:  
Corrosion in steel grating  
over windows. Note that  
it has rusted through at  
this location.

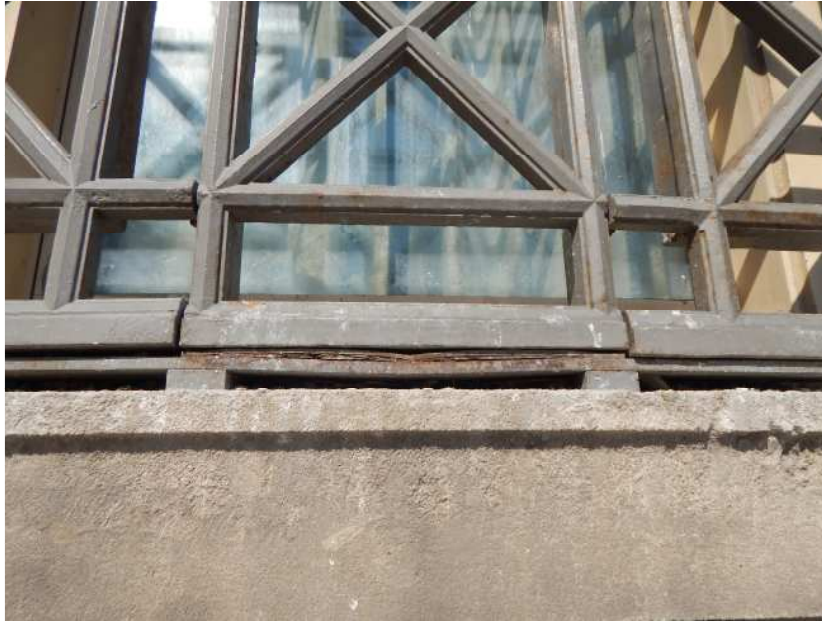
47. South Elevation:  
Corrosion of steel at the bottom of the grating is causing distortion of the framing. This is common on both the south and west elevations.

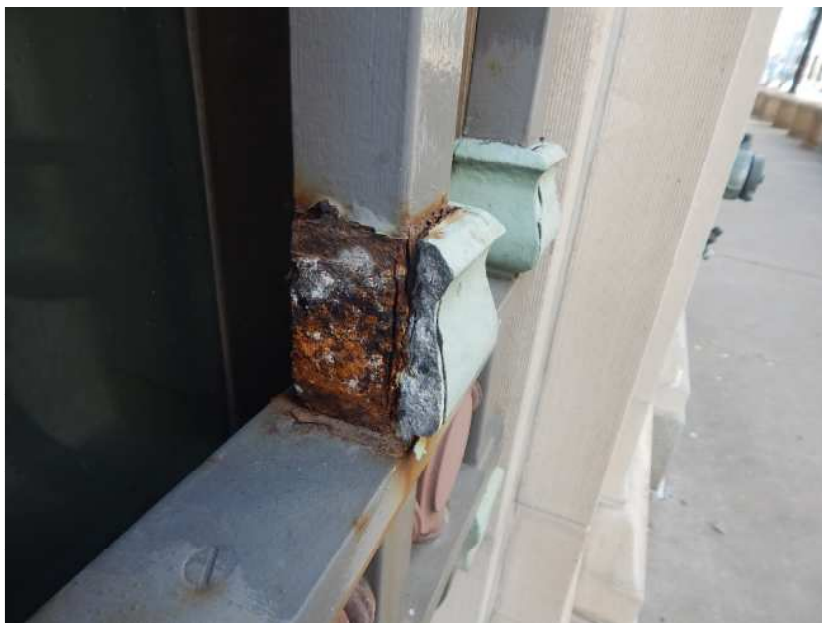
48. South Elevation:  
Corrosion of grating causing damage to decorative elements on both the south and west elevations.

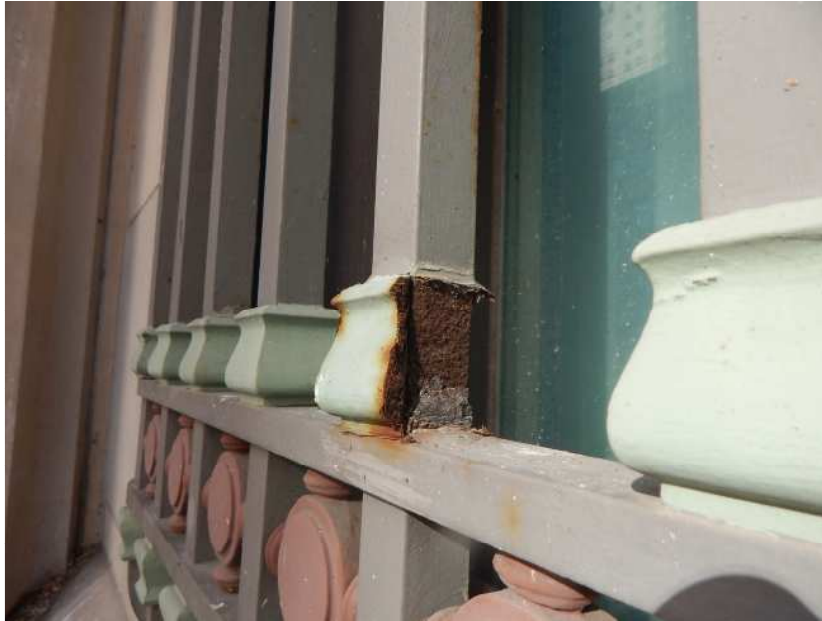
49. South Elevation:  
Corrosion of grating  
causing damage to  
decorative elements on  
both the south and west  
elevations.

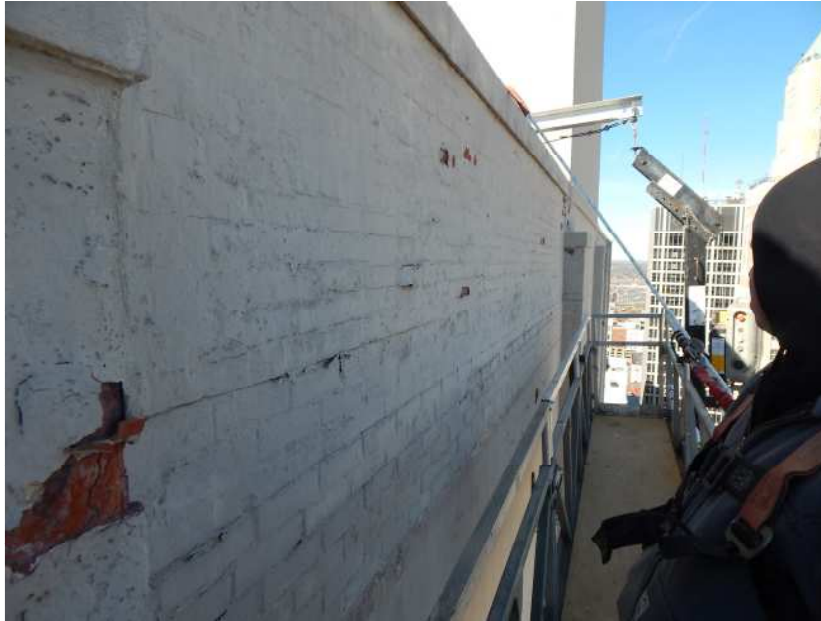
51. North Elevation: Peeling paint and spalling masonry observed on the exterior side of the parapet.

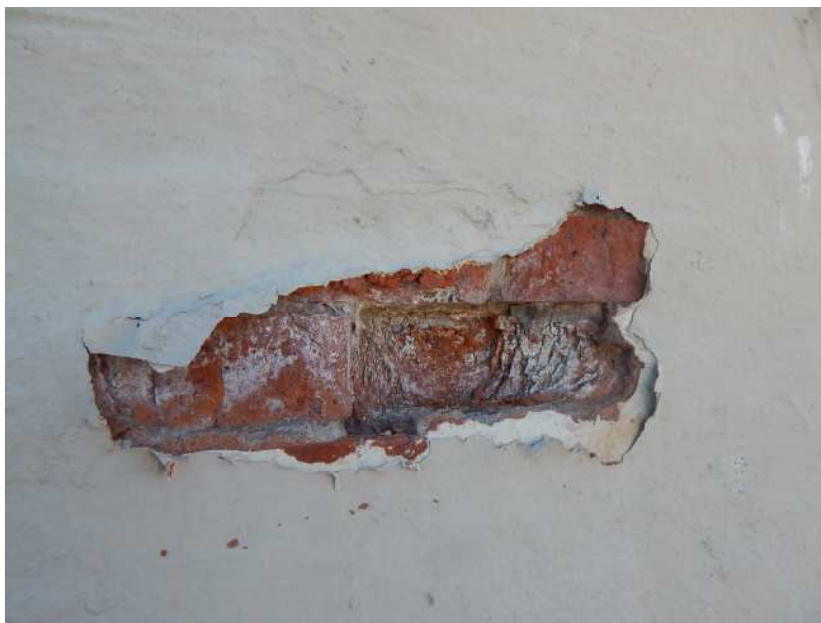
52. North Elevation:  
Example of damage to masonry where paint was observed to be failing.

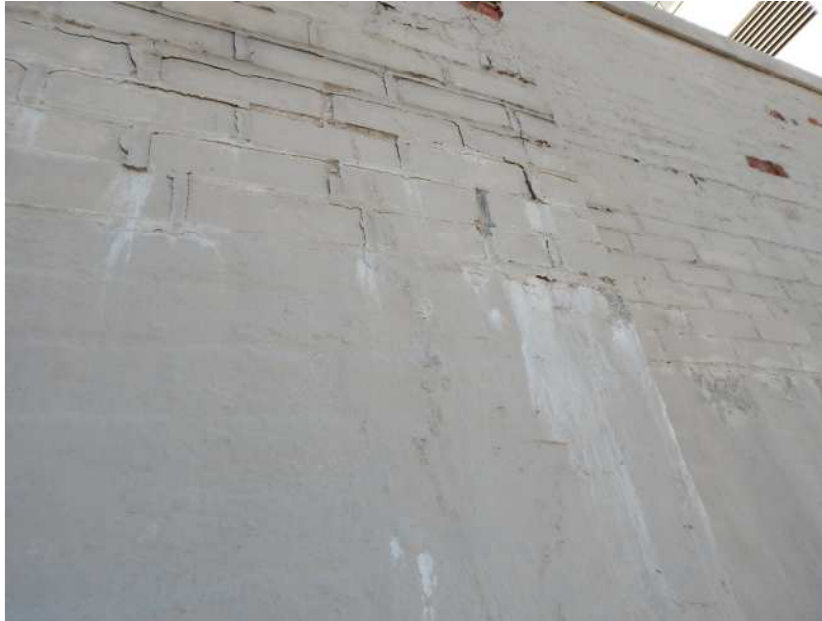
At various locations, but most notably below the parapet cap and at the building corners, the faces of the masonry units are spalling (see photo # 53 and 54). Moisture has infiltrated into the wall and become trapped, causing freeze-thaw damage to the masonry. The cap stones on top of the parapet should be removed, waterproofing installed and the cap stones reset. After these repairs are performed, the masonry can be repaired and recoated to match the existing.

53. North Elevation:  
Efflorescence observed  
on paint on exterior face  
of parapet.

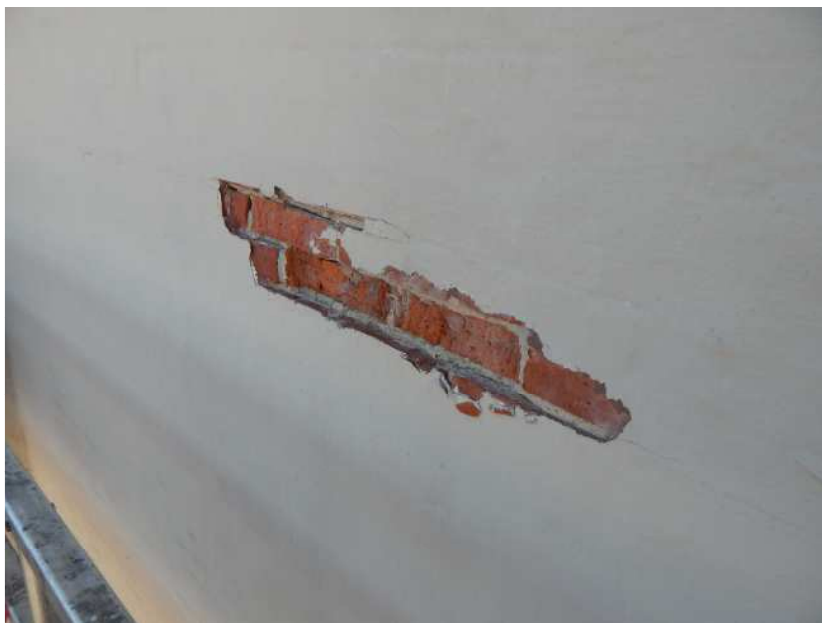
54. North Elevation:  
Example of damage to  
masonry where paint was  
observed to be failing.

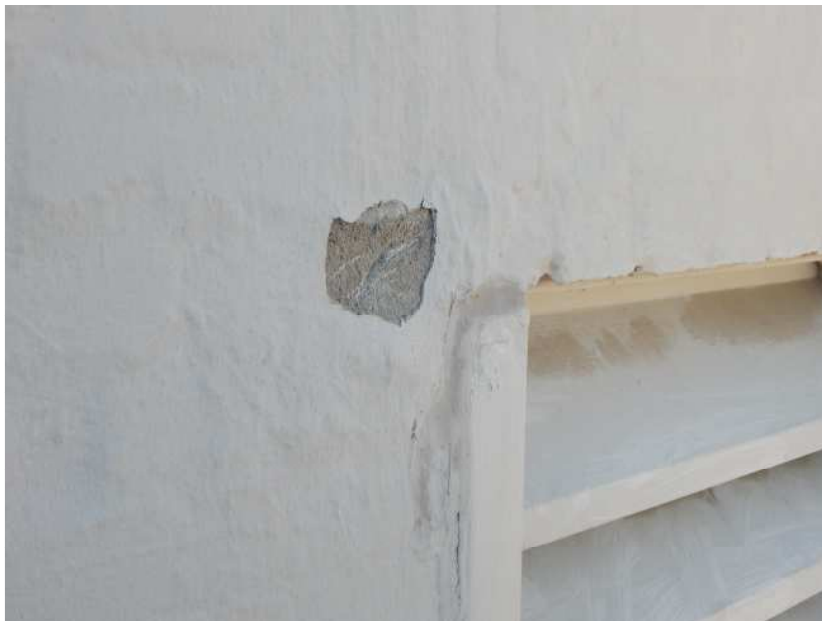
56. North Elevation: Previous repairs to masonry may have included applying a parge coat of cementitious material to damaged areas of masonry.

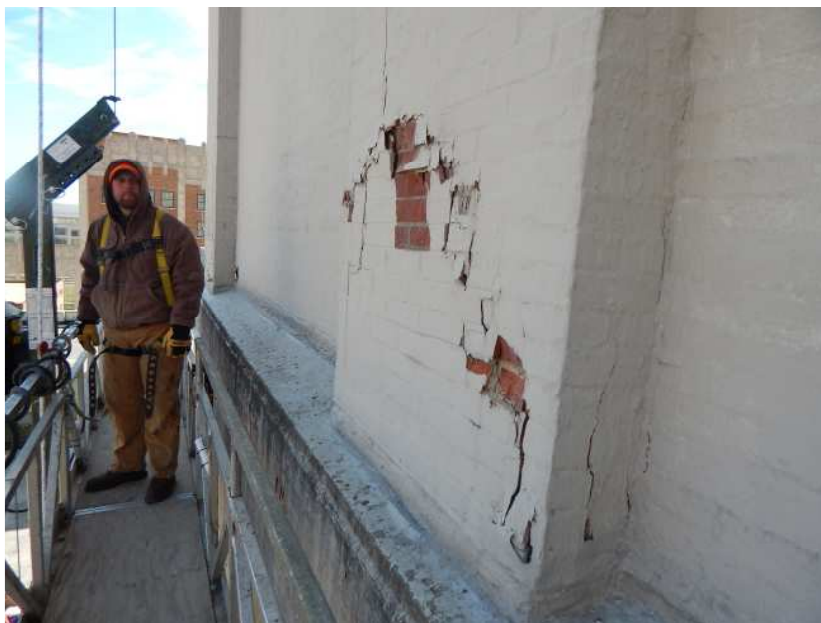
58. North Elevation: Paint and masonry failing at pilaster above the 14" horizontal step in the masonry.

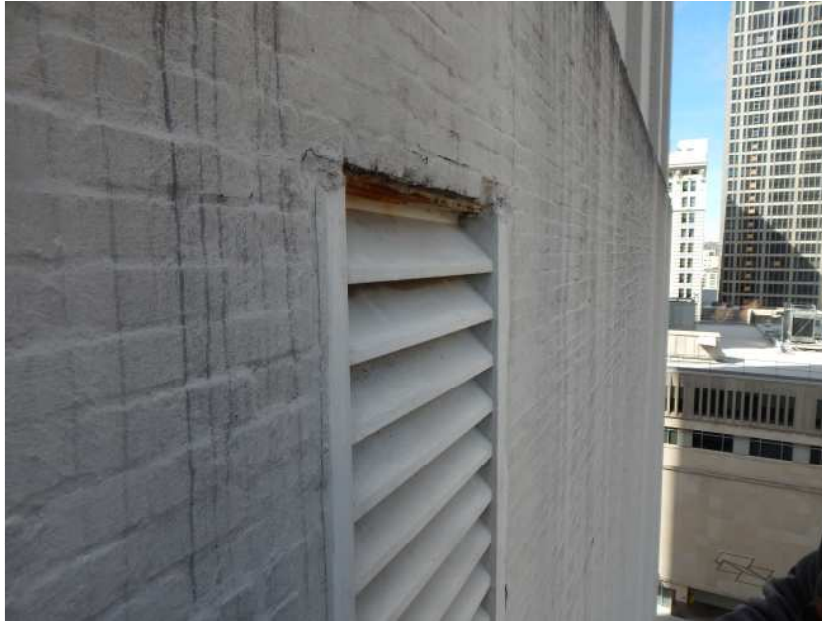
59. North Elevation: Layers of corroded steel observed in brick ledge angle over louver indicating that it needs to be replaced.

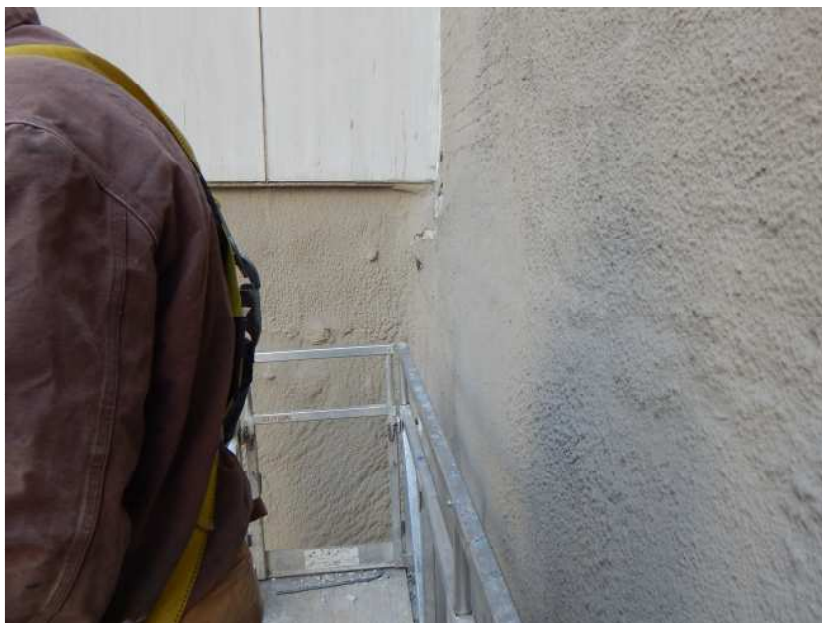
60. North Elevation: No joint added in corner where between building and garage where gunite was added.

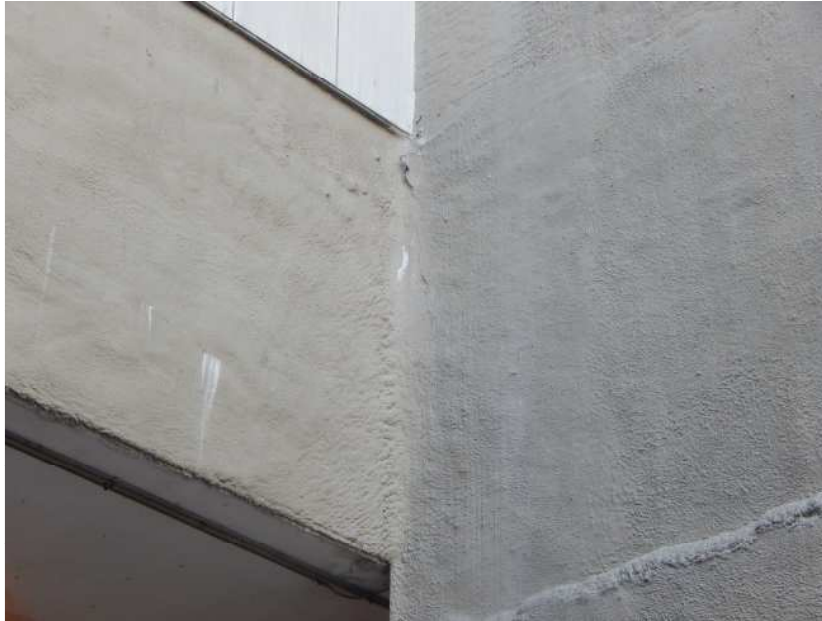
61. North Elevation: Gunite cracked where building meets garage.

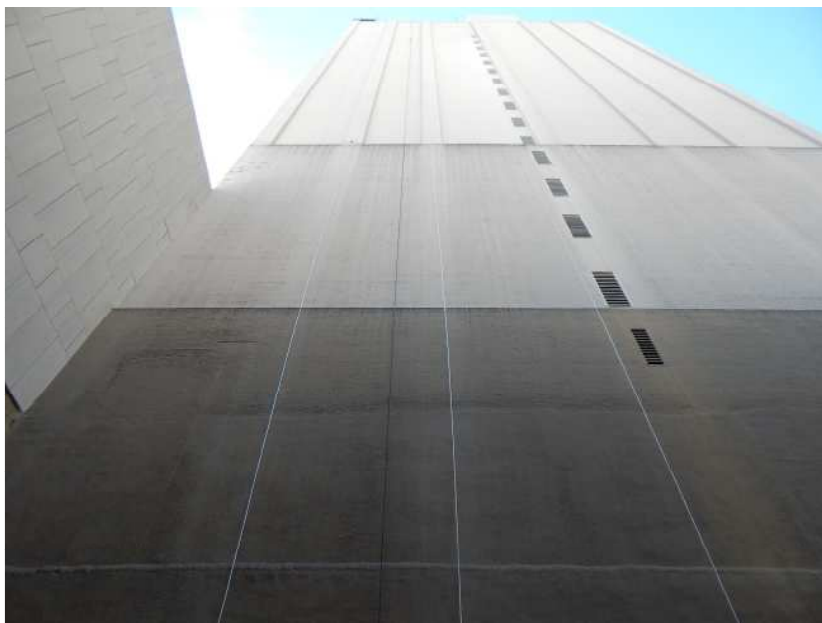
62. North Elevation: Gunite applied to bottom (4) floors of the north elevation.

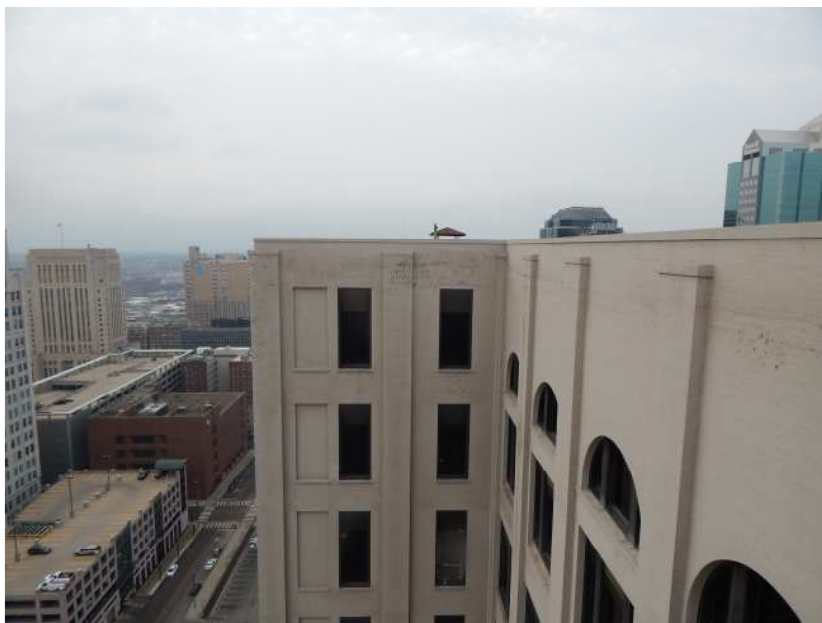
64. East Elevation: Upper north facing portion of the east elevation.

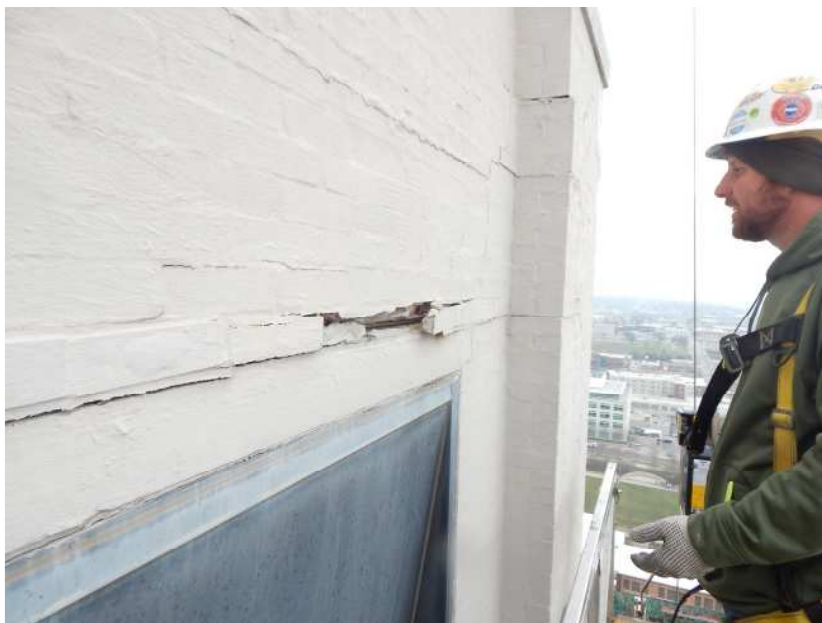
Deterioration of steel framing supporting masonry was observed on the 20<sup>th</sup> and 21<sup>st</sup> floors of the south facing elevation on the east side of the building (see photo # 66 – 68). The existing building drawings indicate that this element is a steel plate attached to the bottom flange of a steel beam. Given the deterioration and movement observed in the masonry at these locations, the plates should be replaced with a new, hot-dipped galvanized steel plate.

66. East Elevation: Corrosion of steel supporting masonry is causing mortar joint to fail.

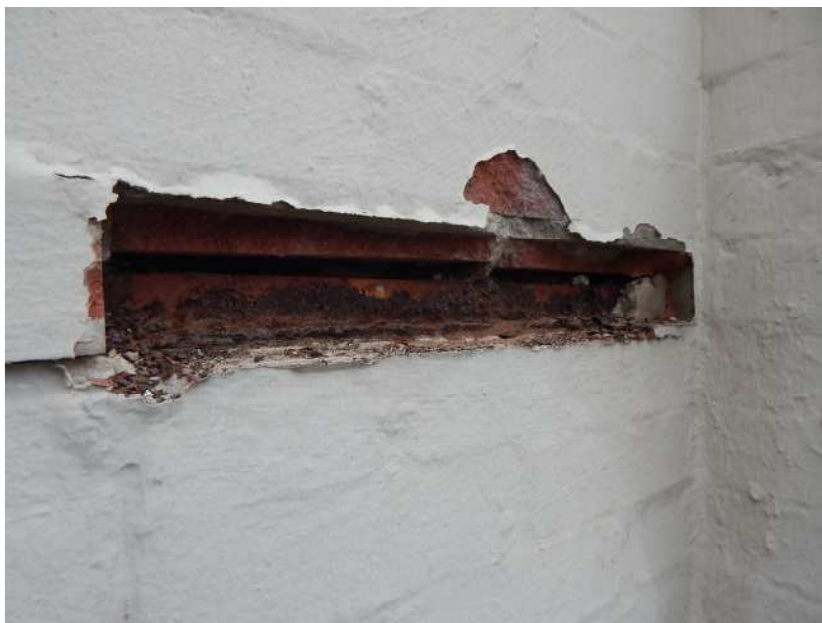
68. East Elevation: Loose partial brick elements removed to reveal large structural steel element.

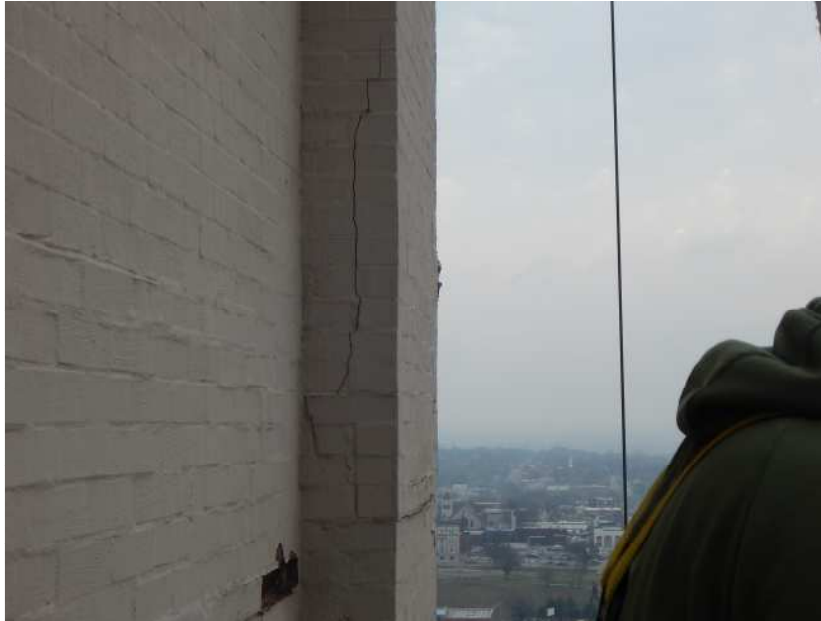
Similar corrosion and movement in the masonry was observed at the pilaster at the east end of the south facing elevation on the east side of the building (see photo # 69). The existing building drawings indicate that this steel element is an angle attached to the building column. This element will also have to be similarly replaced.

69. East Elevation:  
Cracking of masonry at  
corner pilaster likely  
related to corrosion of  
steel supporting masonry  
at this location.

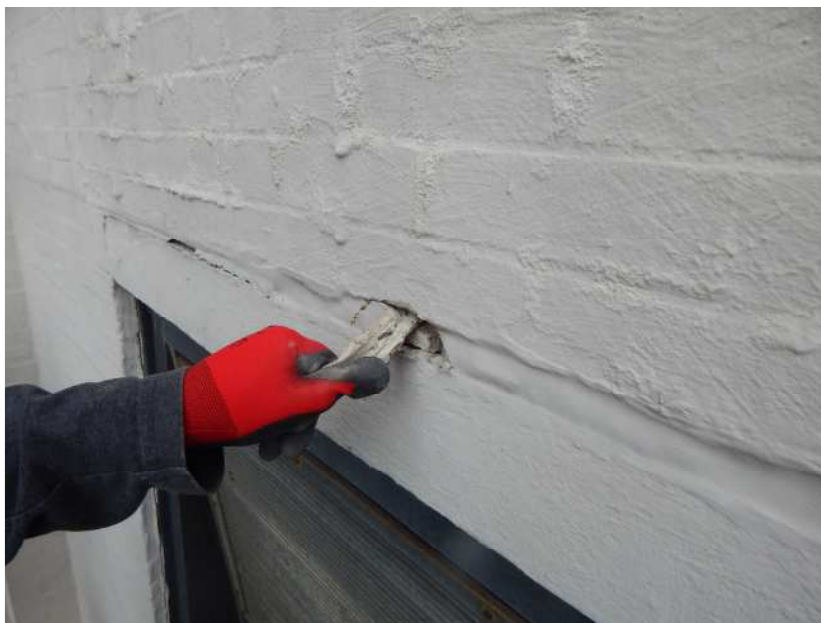
70. East Elevation: Large  
sealant joint typically an  
indication of corroded  
steel in header over  
opening.

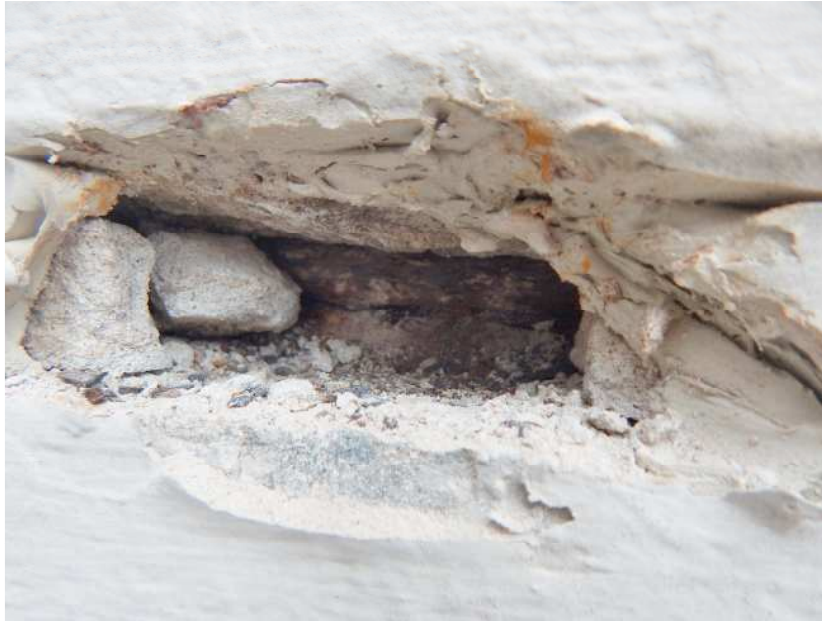
71. East Elevation: Close-up of location in photo #70 revealing corroded steel behind sealant joint.

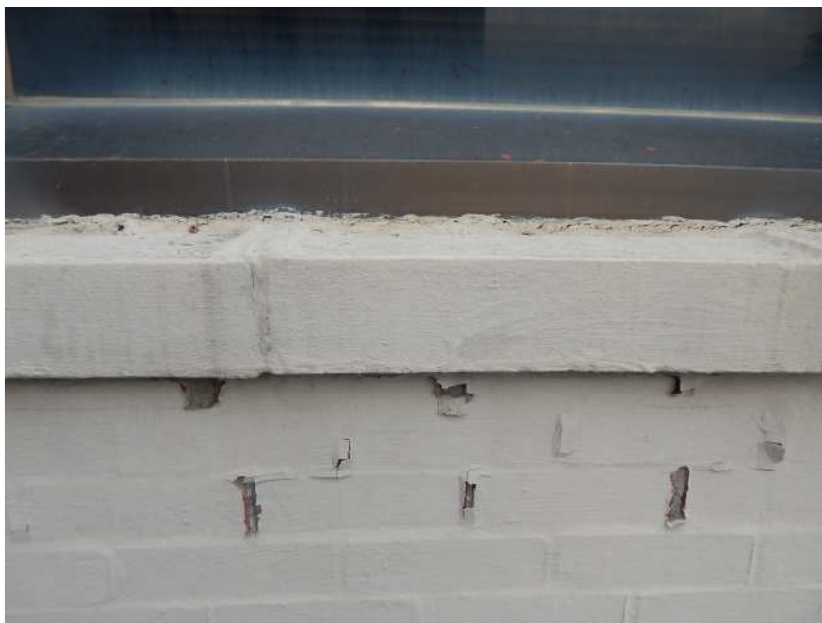
72. East Elevation: Paint system peeling off mortar joints below window.

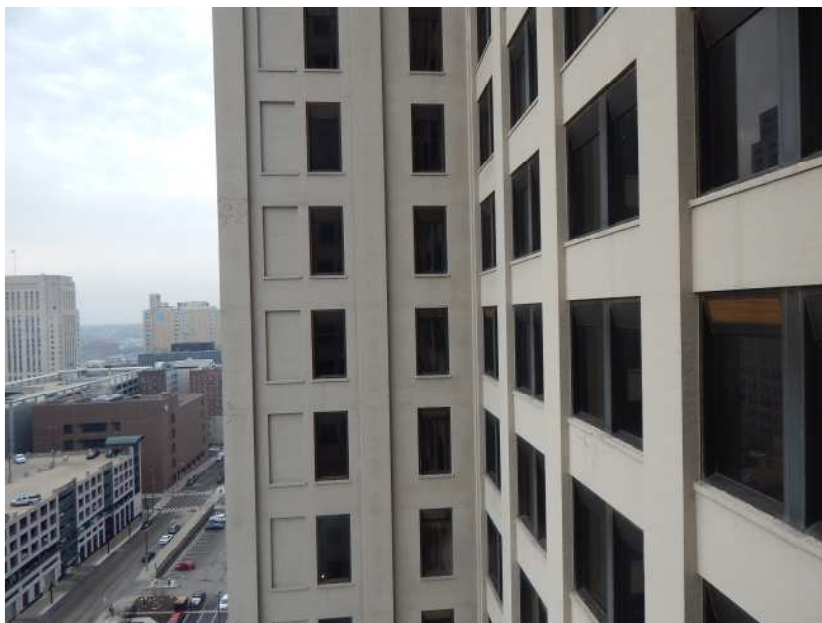
74. East Elevation: South facing portion of east elevation.

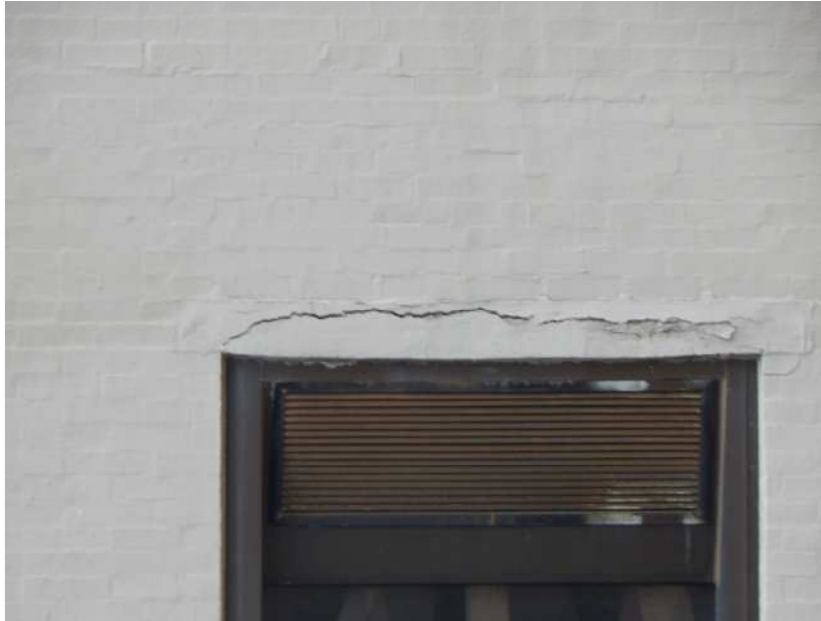
75. East Elevation:  
Deteriorated header  
observed above window  
on the south facing  
portion of the east  
elevation.
