The Grand Reserve  
Addendum for Bidding #2

In general accordance with our Agreement with you dated November 4, 2016, we have completed our review of a select portion of the four primary elevations from a swing stage at the above referenced building. This 21-story building is located at the northeast corner of the intersection of Grand Avenue and E. 10<sup>th</sup> Street, and was built in 1921. The purpose of this review is to visually examine the condition of the building facade and provide repair recommendations with cost estimates based on our findings. Our on-site reviews occurred on March 2 to March 17, 2017.

**FORMER FEDERAL RESERVE BUILDING  
925 GRAND BLVD  
KANSAS CITY, MO**

**MARCH 31, 2017  
JOB #2017-0368**

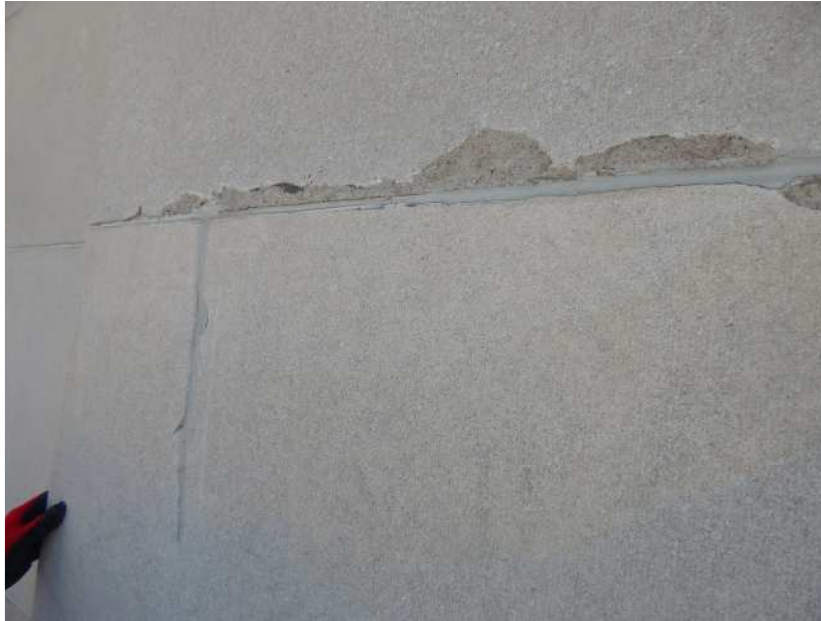
15. West Elevation:  
Example of chipping of  
bottom corner of stone.

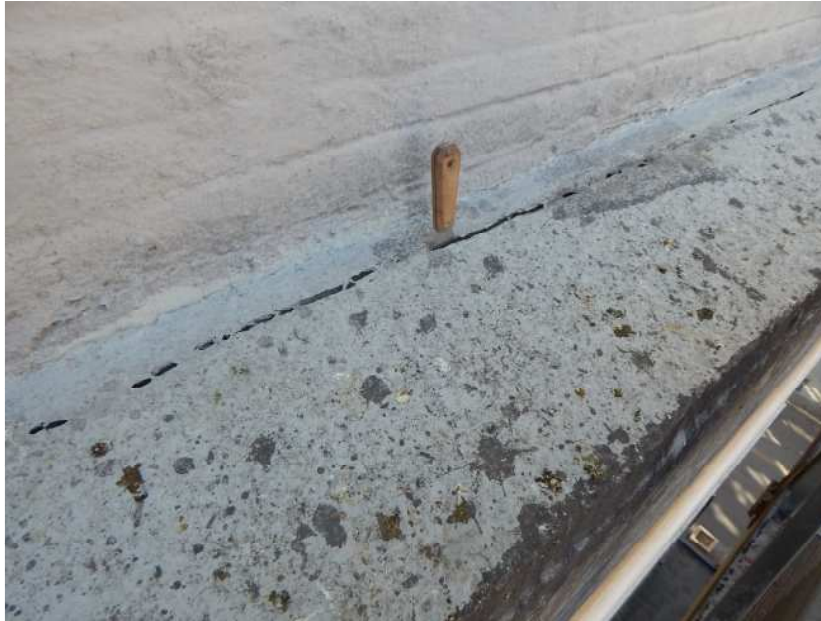
57. North Elevation: Joint at the back of a 14" horizontal step in the masonry is open and will allow water directly into the wall.

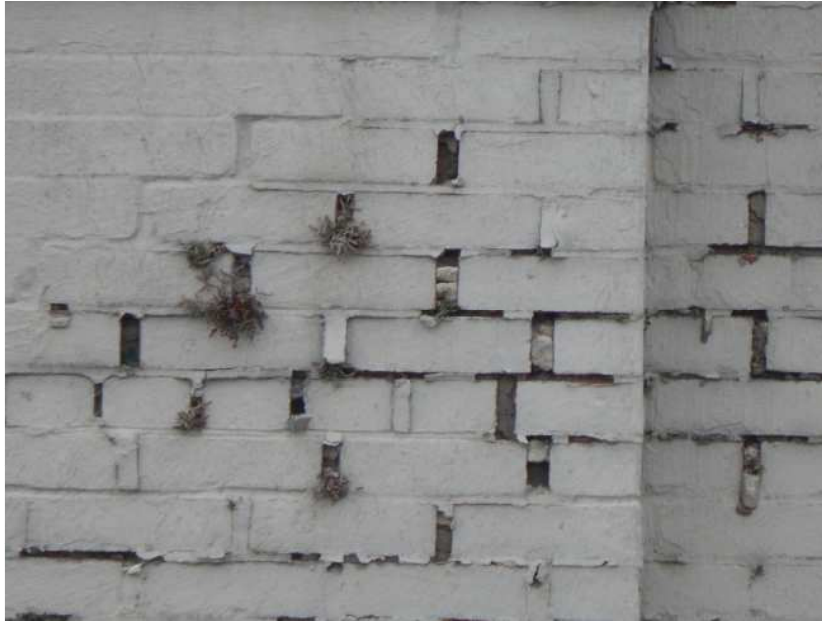
65. East Elevation: Close up of organic growth in mortar joints at the location shown in photo #64.

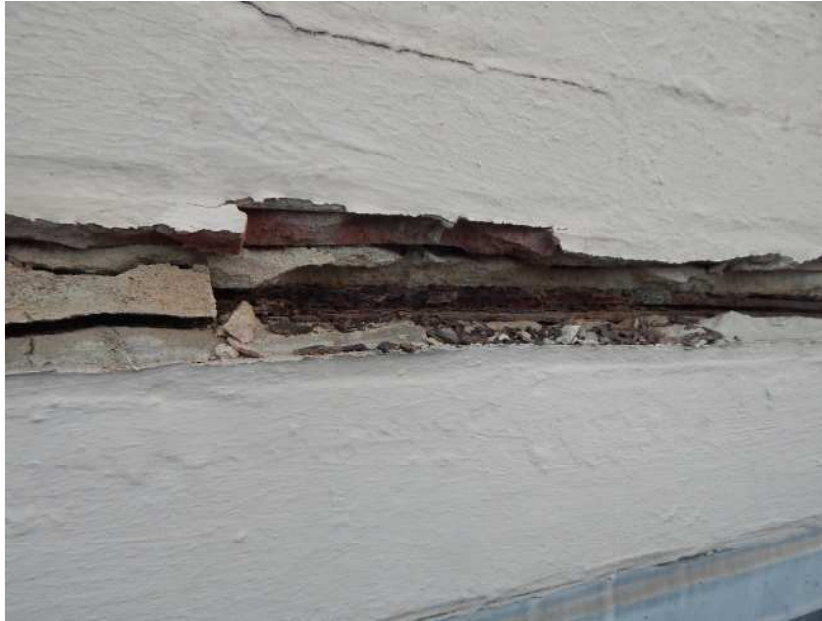
67. East Elevation: Close-up of location shown in photo #68.

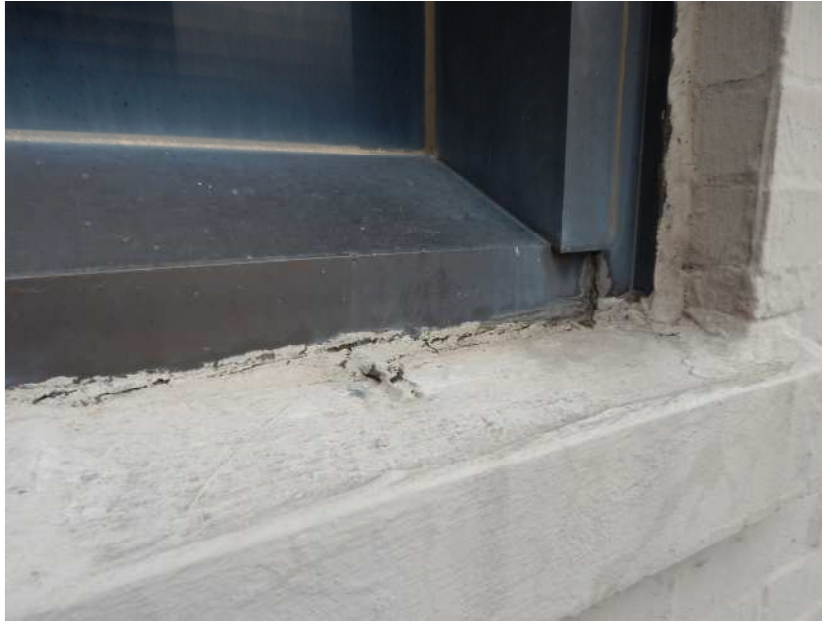
73. East Elevation: Weep installed below window and onto sill has been covered with paint.
